The 46th ANNUAL TSDOS

TRANSMISSION AND SUBSTATION DESIGN AND OPERATION SYMPOSIUM

September 11 - 13, 2013

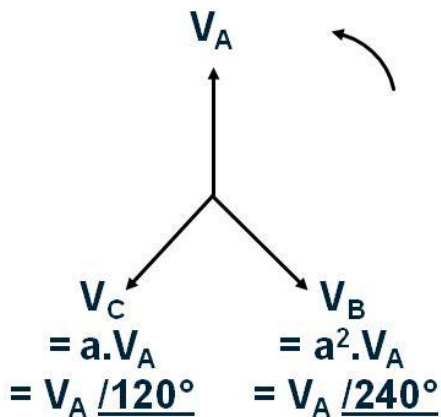
Calculating normal and abnormal system conditions starts with an understanding of symmetrical components. Symmetrical components first came about in a paper written by Dr. C. L. Fortescue entitled, "Method of Symmetrical Coordinates Applied to the Solution of Polyphase Networks." [1] Dr. Fortescue stated that unbalanced three phase voltages or currents could be transformed into three sets of balanced three phase components. To do this mathematically, the method of symmetrical components utilize a variable called the "a" operator. This variable is a vector with a magnitude of 1 and an angle of 120°. In a three phase system, the "a" operator is applied to the reference voltage or current. By applying the "a" operator to the reference voltage and current phases they are each rotated counter clockwise by 120°. To get a 240° displacement, the "a" operator is squared. This is shown in Figure 1 below where the "B" and "C" phases of voltage are expressed in terms of "A" phase voltage. This same procedure would apply to current as well.

Figure 1. Application of the "a" Operator

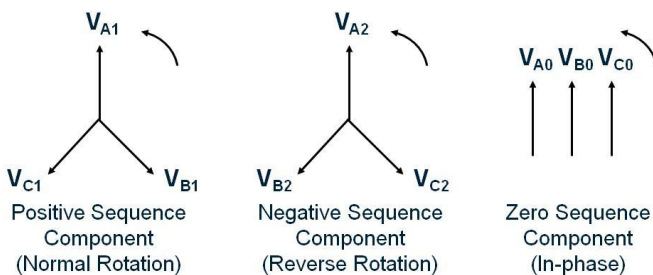
Now that each of the phases are expressed in terms of a common reference, they can be broken down further into their actual sequence components. All three phases will each contain three components called positive, negative, and zero sequence. These are shown in Figure 2.

Figure 2. Positive, Negative, and Zero Sequence Components

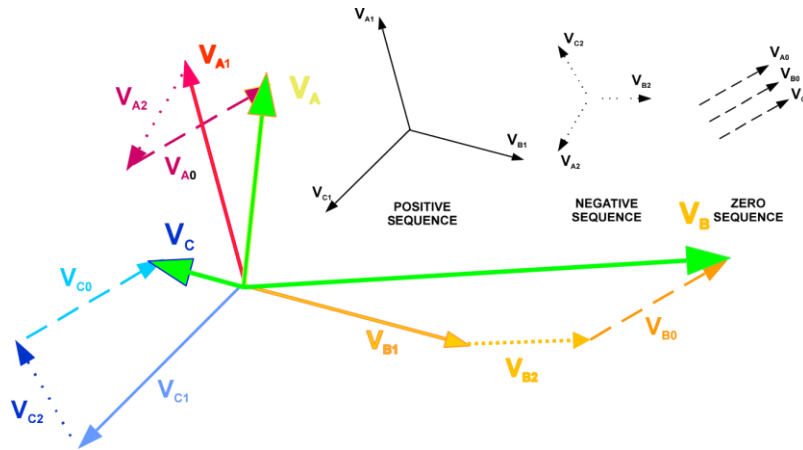
Now that we have these equations, what do they mean? To put these equations in perspective, let's show how the relationship between phase voltages and currents with their sequence components. Figure 3 shows how each of the phase quantities are a vectorial summation of each of their respective sequence components.

Figure 3. Relationship between symmetrical components and phase components

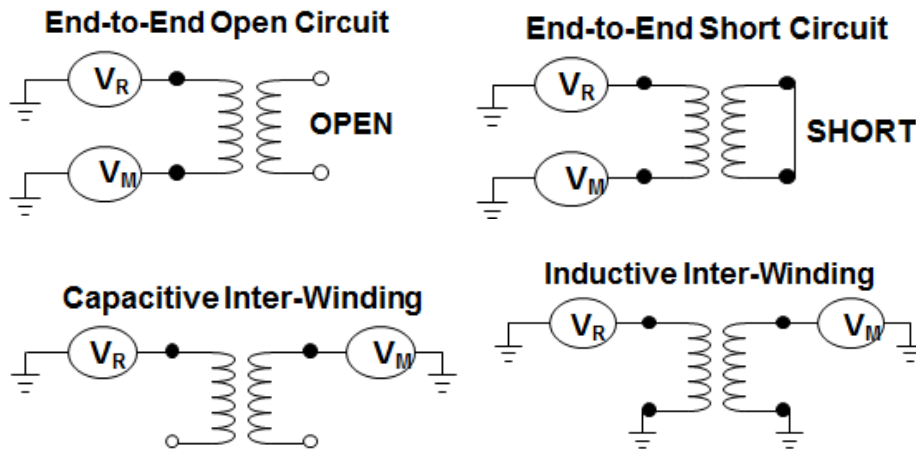
Figure 1 illustrates the four measurement types. V_R is the applied signal and V_M is the measurement of the response. The connections shown below represent single phase configuration of a transformer. For three-phase configuration similar tests would be performed on each phase.

Figure 1: Measurement types

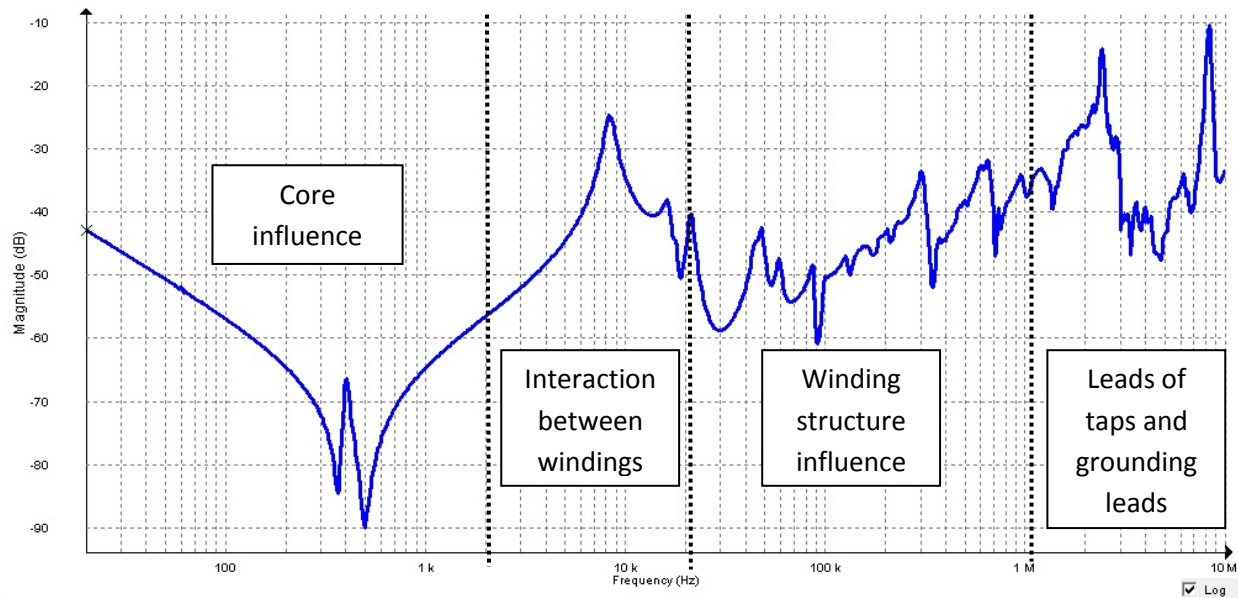
Figure 2 below shows a typical response from 20 Hz to 10 MHz, a plot of admittance magnitude vs. frequency. The frequency normally is presented in logarithmic scale and the magnitude is usually shown in decibels. Linear scale for the frequency and the magnitude are used occasionally as well. The entire trace can be divided into four regions depending upon the predominant component influence: core, winding interaction, winding structure, leads of taps and grounding leads. The frequency range for different regions shown below in figure 2 can be used as a general guideline, however it may vary based upon different transformer designs.

Figure 2: FRA trace showing influence of transformer components in different frequency regions

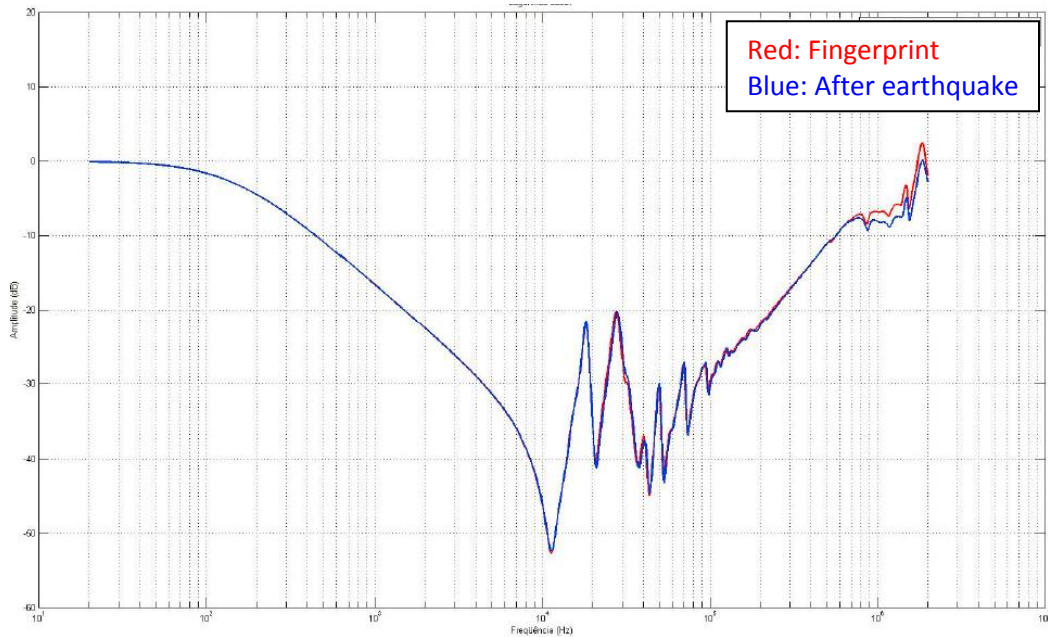
Figure 5: Autotransformer 3, comparison of short circuit responses before and after earthquake

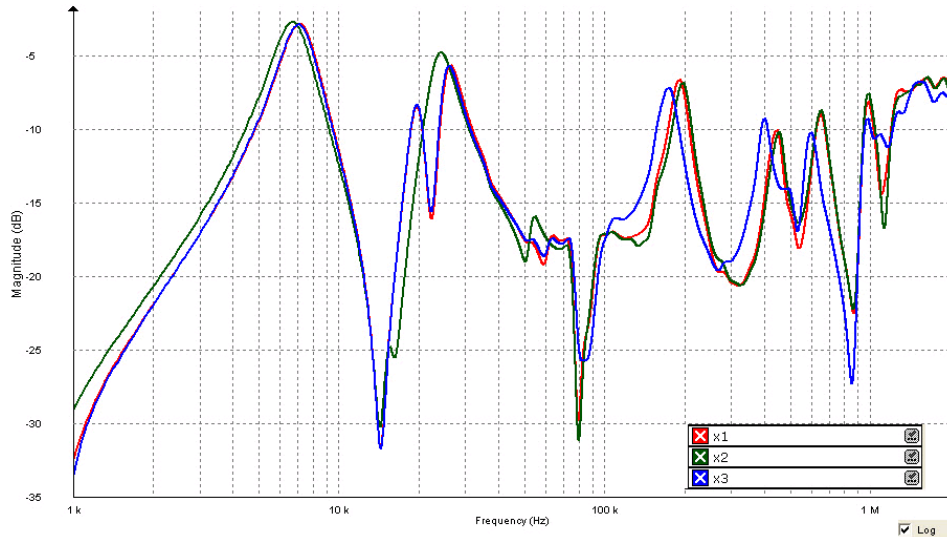
FRA open circuit tests were performed on both high and low side windings of the transformer. The following results were observed when all three LV windings were analyzed.

Figure 6a: FRA Open Circuit Test of LV windings for all phases

All three phases were compared to determine any mechanical changes within the transformer. As shown in Figure 6a above, the three LV windings showed a lot of asymmetry in the frequency range of 50 kHz- 1 MHz. Possible LV winding geometry change was suspected based upon the FRA curves. Results were further analyzed to compare A (X1-X0) and C (X3-X0) phases traces that should have similar resemblance.

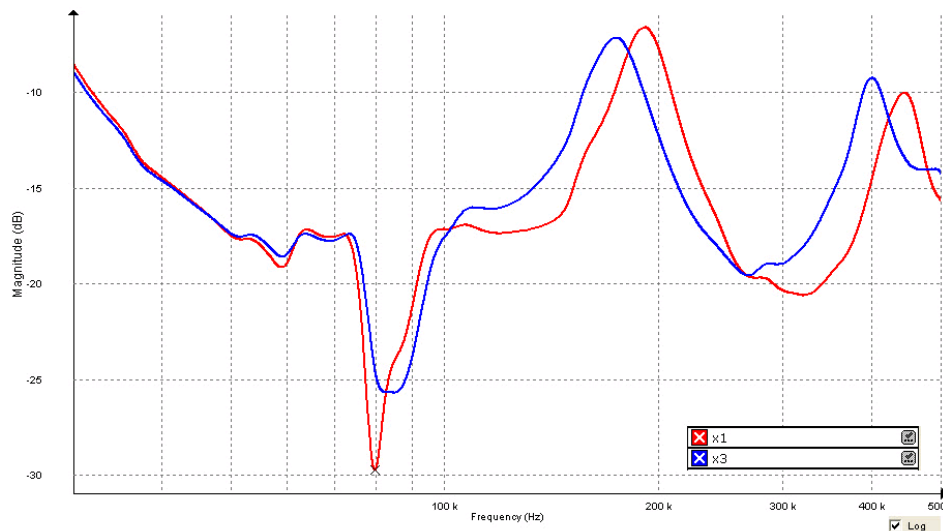
Figure 6b: FRA Open Circuit Test of LV windings for phases A & C comparison in 50 kHz to 500 kHz range

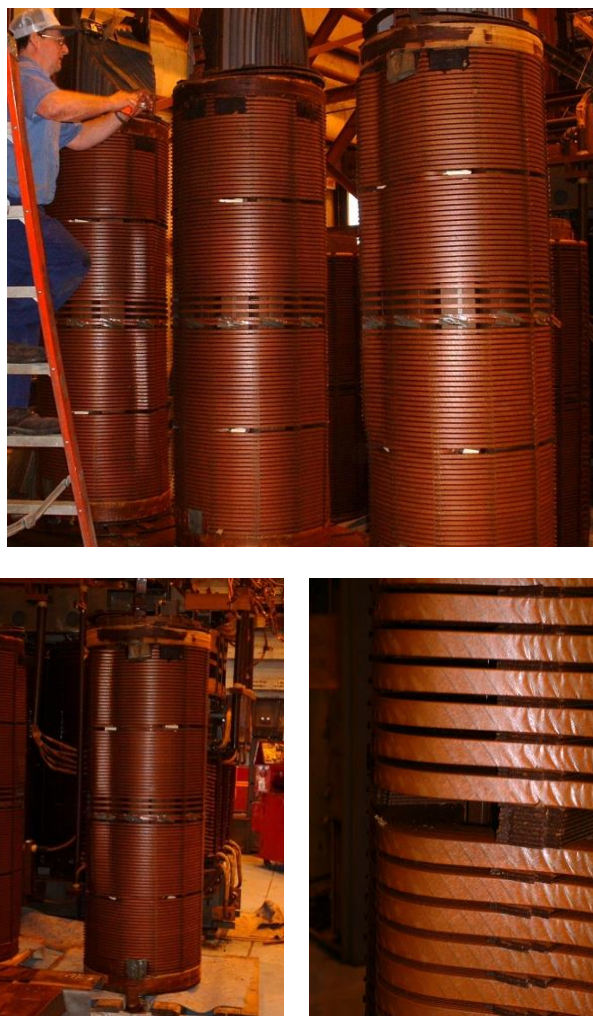
Transformer was sent for inspection and repair. Upon de-tanking and tear down, it was found that all three low side windings were severely deformed showing signs of radial buckling due to lack of strength to withstand through fault conditions.

Figure 7: All three LV windings showing radial deformation (hoop buckling) and close up on phase C

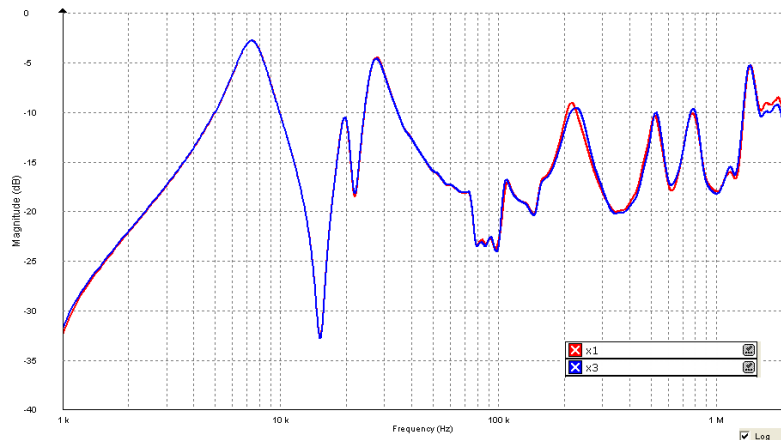
After diagnosing the problem, the transformer was rebuilt and put back in service at a different location. A new FRA fingerprint (as shown in Figure 8) was taken before putting it back in service for any future investigation and analysis.

Figure 8: FRA Open Circuit Test of LV A and C phase windings after rebuild

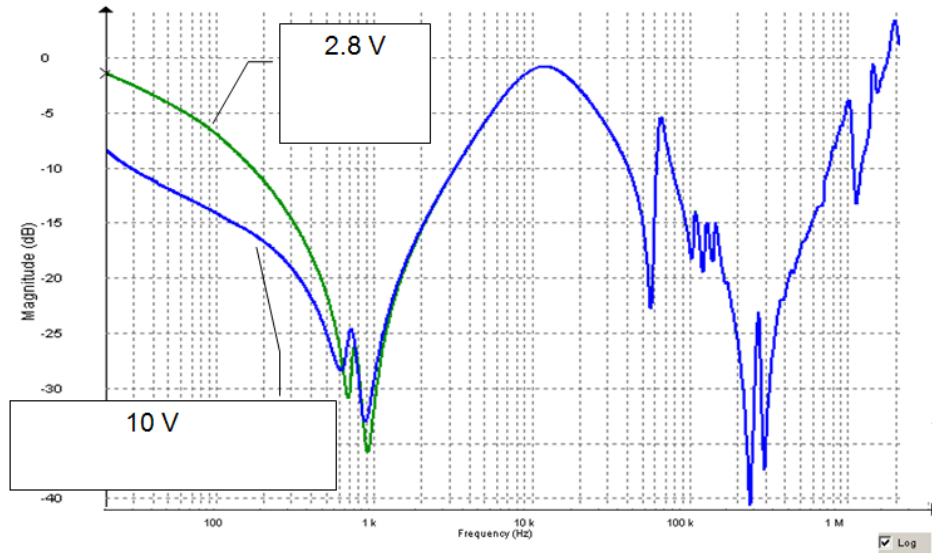
- 2) Applied voltage can affect the FRA response in the lower frequency region up to 10 kHz. To obtain repeatable test results for comparison, it is recommended to use same test voltage applied in past for obtaining baseline results or when comparing traces between similar transformers. It is advisable to check the voltage used in previous tests before running a test or if the traces do not match below 10 KHz.

Figure 9: Comparison of tests performed at different voltages

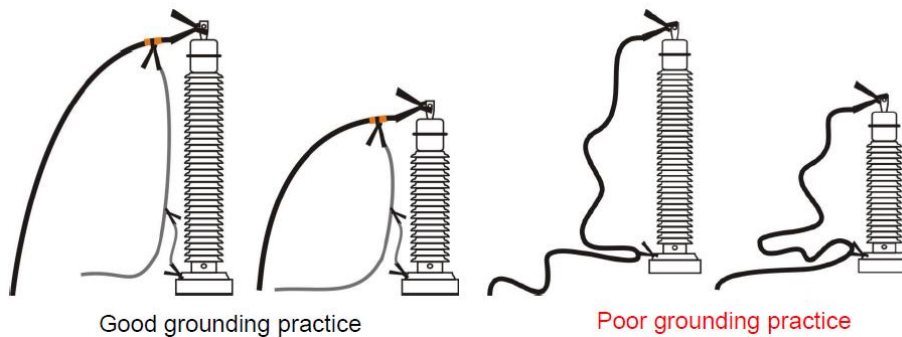
- 4) Ground connection is the reference for both source and measuring leads. It is very important to apply the same grounding practices each time to obtain consistent and repeatable results. Inconsistent grounding practice can greatly affect the high frequency region of the FRA trace. One of the methods to accomplish this is to use "shortest possible ground" technique. The goal should be to provide the source and measuring leads the closest ground (reference) point with shortest length of ground braid. Figures 10a and 10b below shows the best grounding practices to be used in field.

Figure 10a: Effective use of flat braid ground wire

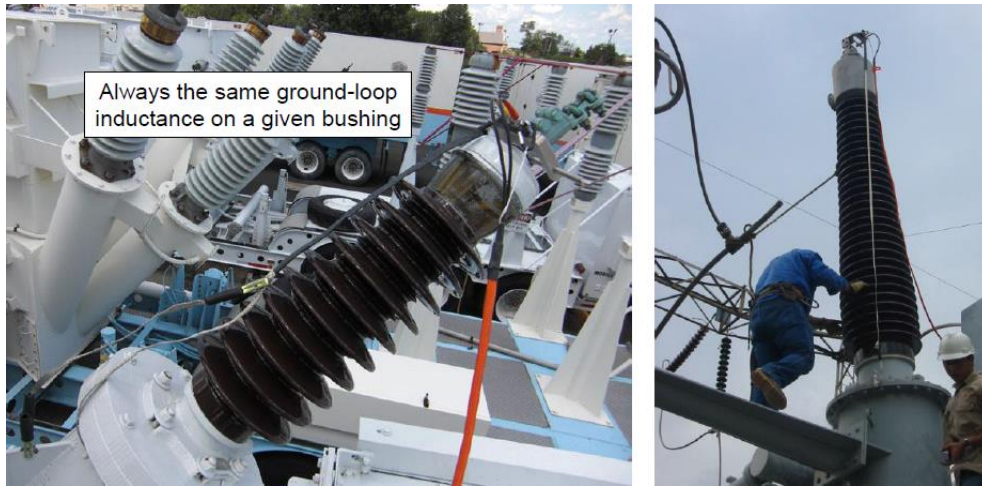
Figure 10b: Best grounding practices in field environment

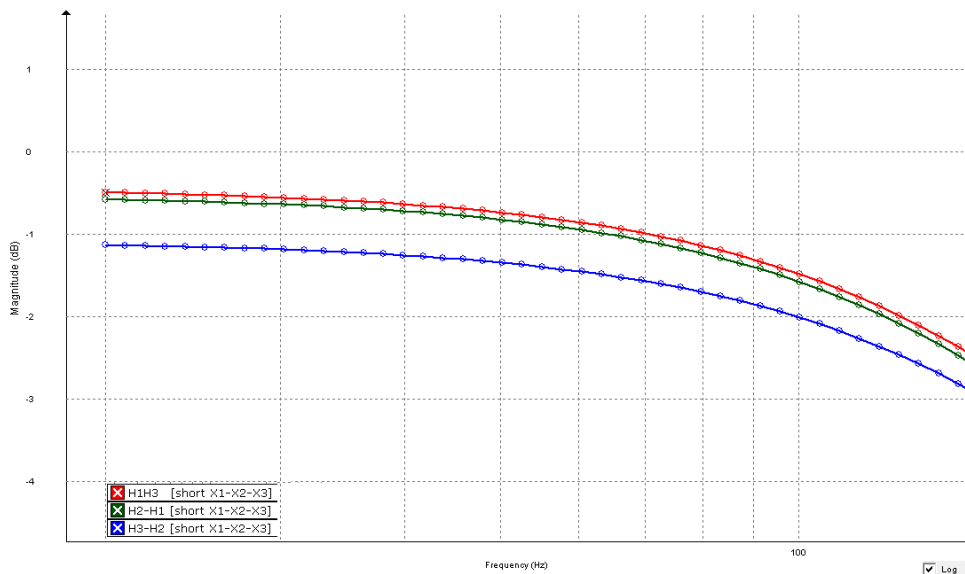
When above FRA trace is zoomed in for frequency less than 100 Hz, a noticeable difference between the three phases can be observed as shown in figure 14. This analysis supports the questionable readings obtained in winding resistance test.

Figure 14: Detail of the short circuit results below 100 Hz

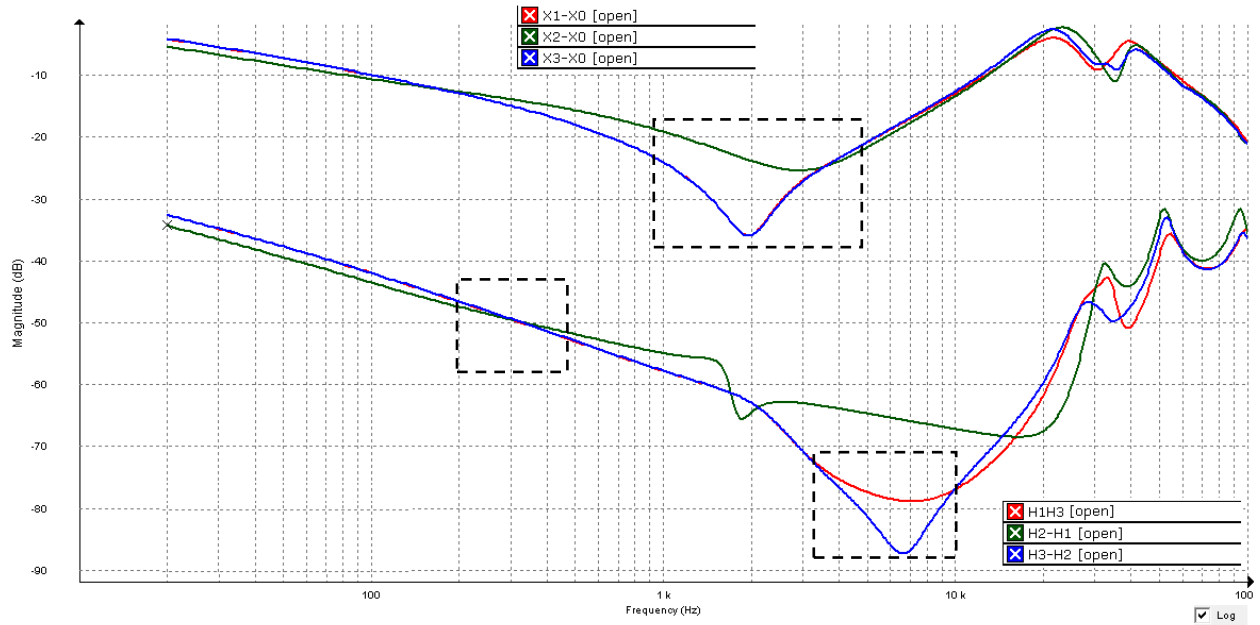
Figure 15: Open circuit results for HV and LV sides for all the three phases

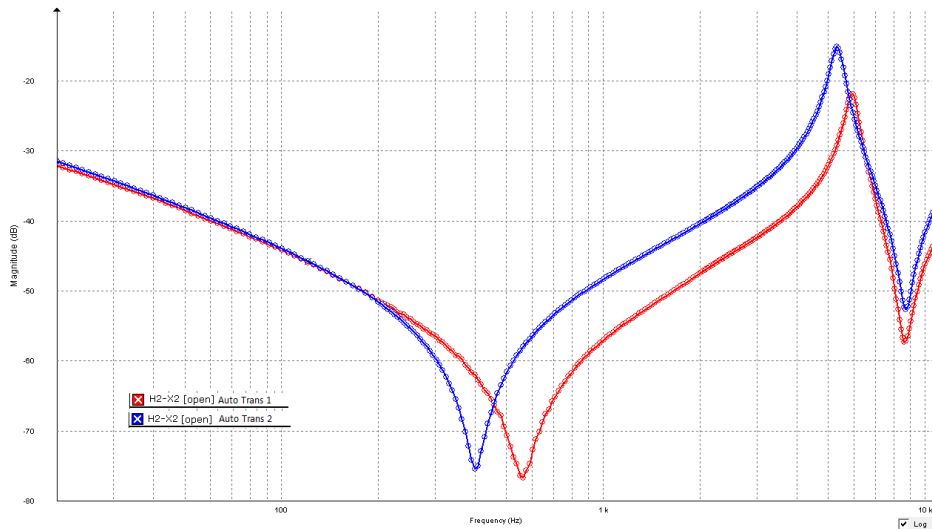
Figure 19: Comparison of autotransformers 1 and 2, low frequency area detail

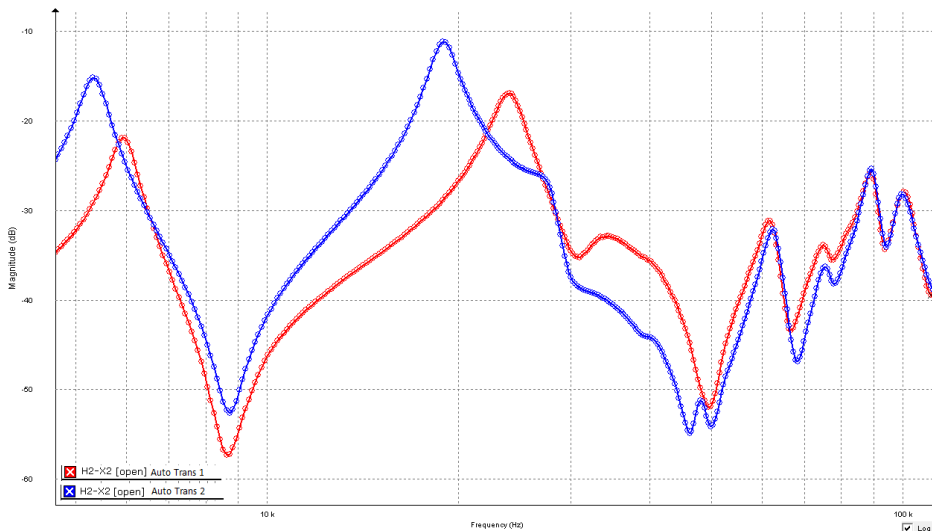
Figure 20: Comparison of Autotransformers 1 and 2, mid frequency area detail

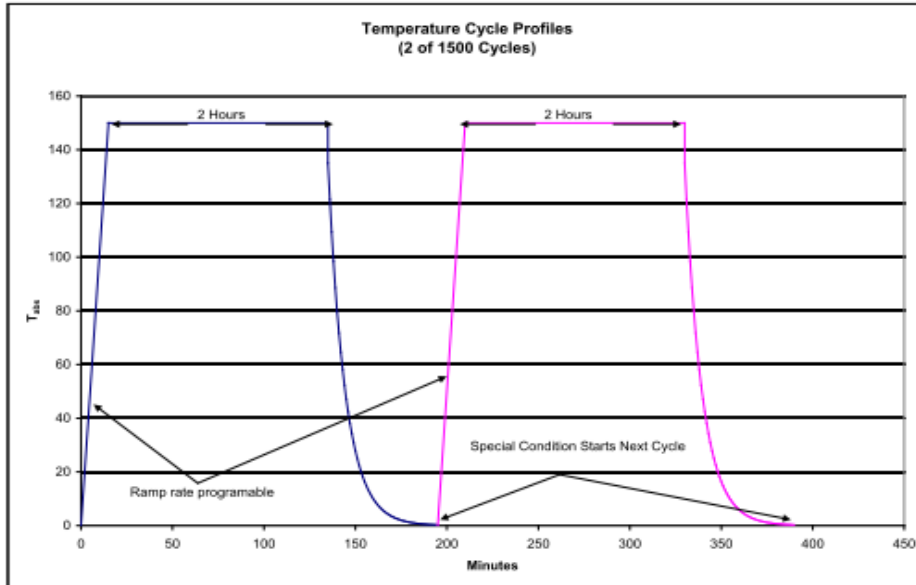
Figure 3-1
Thermal Cycle Design

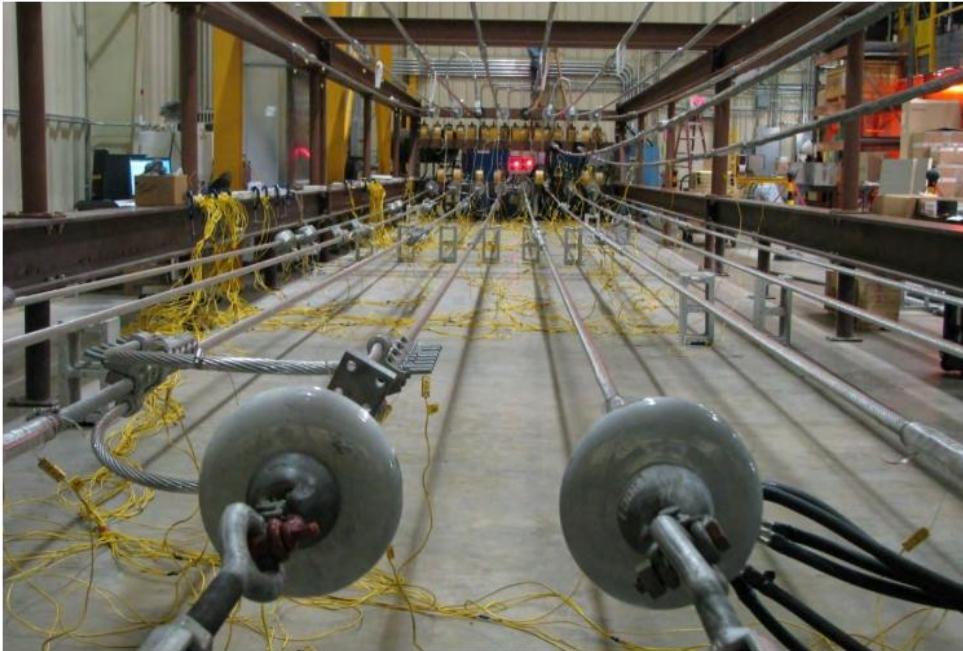
180°C for 1,500 cycles. This was designed to emulate as nearly as possible a long term high temperature duration field condition tension performance test with temperatures nearly emulating ANSI C119.4 Class AA performance test temperatures.

Figure 3-1
Test Conductors

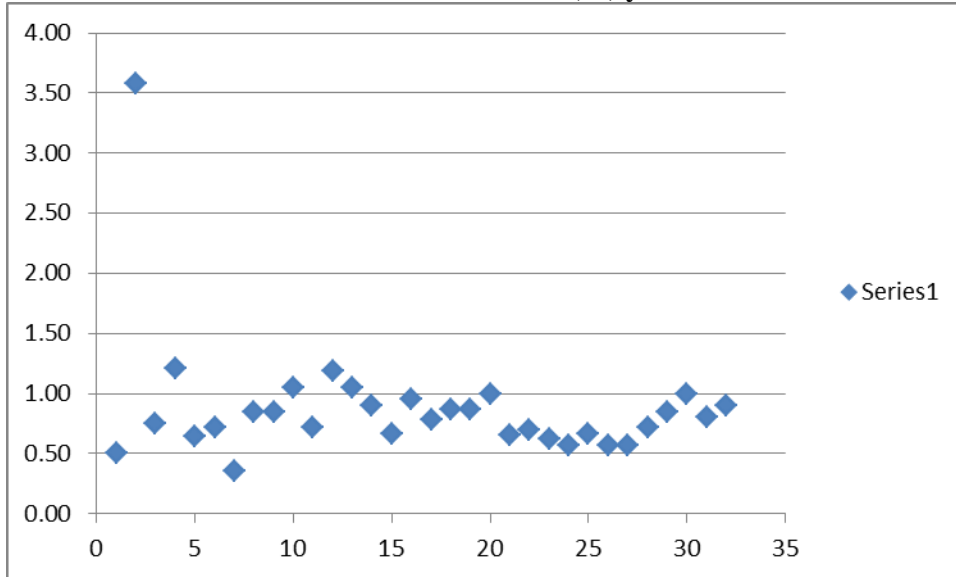
Resistance Ratios of Tension connectors Ten (10) years old:

There were quite a few of the original tension connectors with a resistance ratio of 1.5 – 3.0 indicating that they are due for replacement. Obviously, there was one connector in the critical range of 3.5.

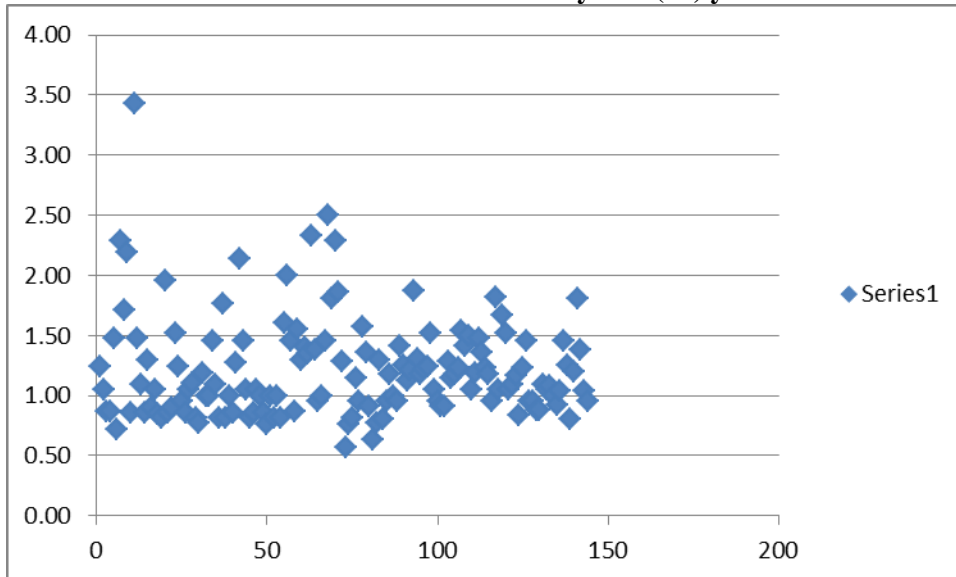
Resistance Ratios of Tension Connectors Forty-two (42) years old:

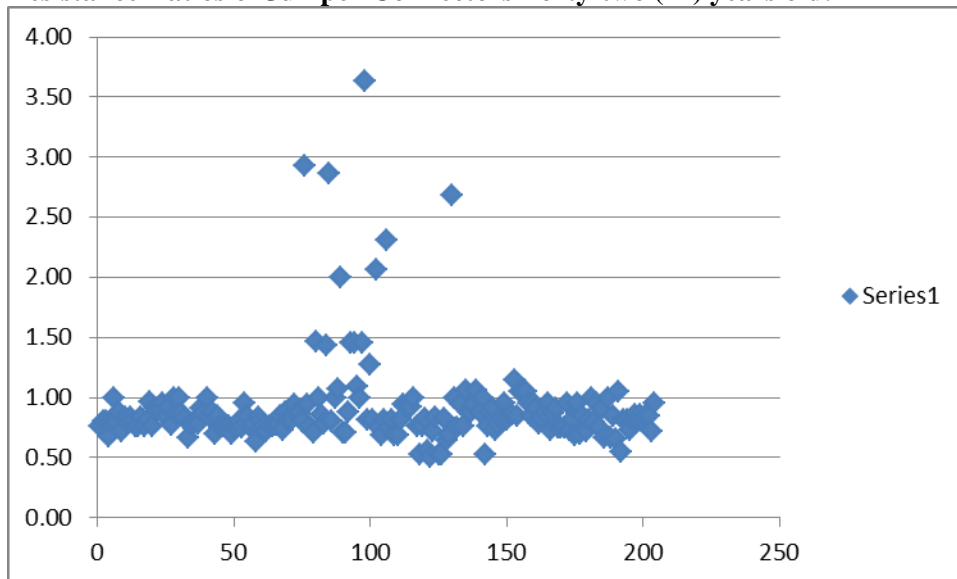
Resistance Ratios of Jumper Connectors Forty-two (42) years old:

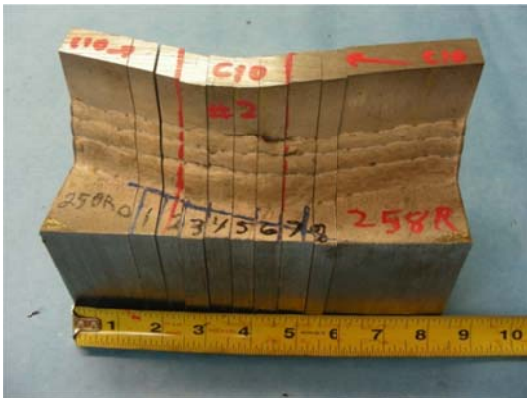
Figure 1.

The below figures represent the analysis of a single indication that was found in an inspection of a base plate to tower weld. Multiple cuts were made to analyze the indication found.

A single indication was reported by UT. It was characterized as 2.0" L x 0.75" W x 0.12" D. The section containing that defect was sent for metallurgical analysis.

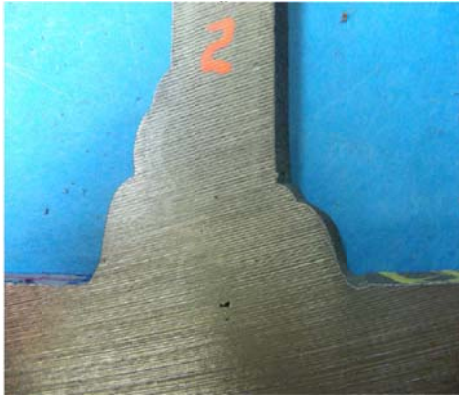
Figure 2.
Examination of the cut slices revealed a defect.

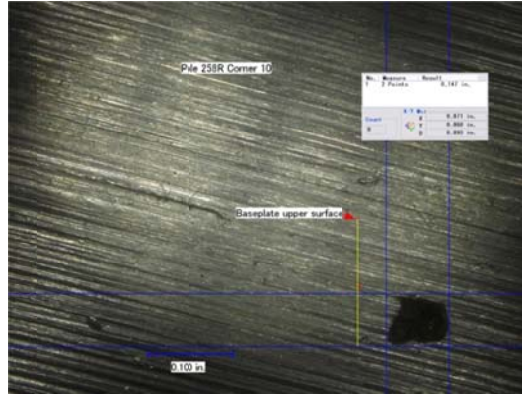
Figure 3.
Under 20X magnification, an indication is shown. Exhibited a small slag defect in the center of the weld at the base of the weldment. Actual flaw was less than 0.1" on a side and only 0.5" long.

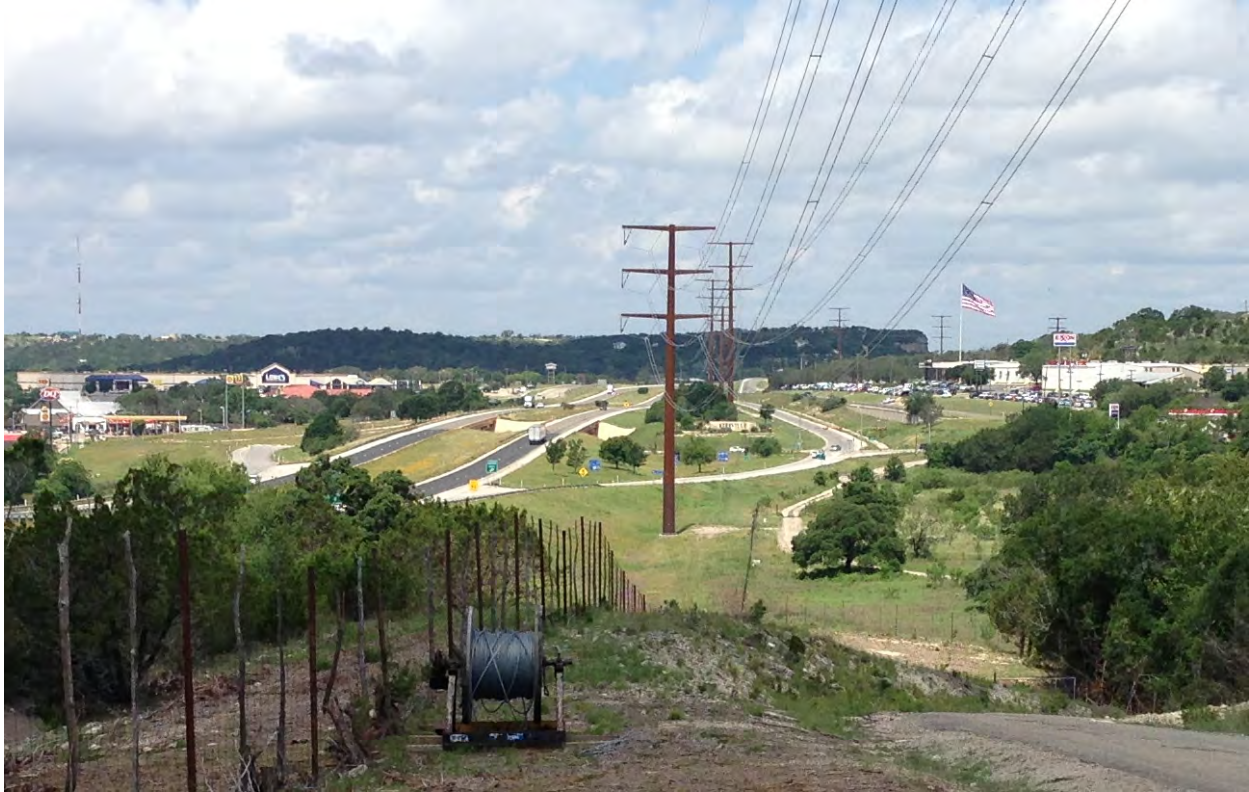
After seeing a draft of the design in July 2012, officials from the City of Kerrville objected to the design as proposed, claiming that LCRA had not followed through with the earlier agreement. While LCRA disagreed with this assessment of the situation, they engaged the City through TxDOT and found that the City was primarily concerned about the proximity of the pole in the monument area to the “Kerrville” sign, and in the amount of vegetation that would be removed as a result of the draft design. Seeing an opportunity for a final resolution of its differences with Kerrville, and the potential for a mutually beneficial solution, LCRA’s engineering team revised the design to increase the height of the structure to maintain a safe clearance over existing vegetation and maximize the distance from the pole structure to the “Kerrville” sign. Also, in order to protect the travelling public during a complicated construction sequence, LCRA worked closely with TxDOT on the placement of barricades, the installation of new guardrails, the timing of crane and helicopter operations, and the deployment of law enforcement to carry out the traffic control plan. With the revisions to the design and all construction arrangements made, LCRA submitted the permit for the intersection in Kerrville and obtained approval in January 2013. By May 2013, structures were installed, wire was pulled in, and construction was complete through the intersection. Figure 6 is a photo of the line constructed through the intersection.

Figure 6: Big Hill to Kendall Transmission Line through Intersection, June 2013

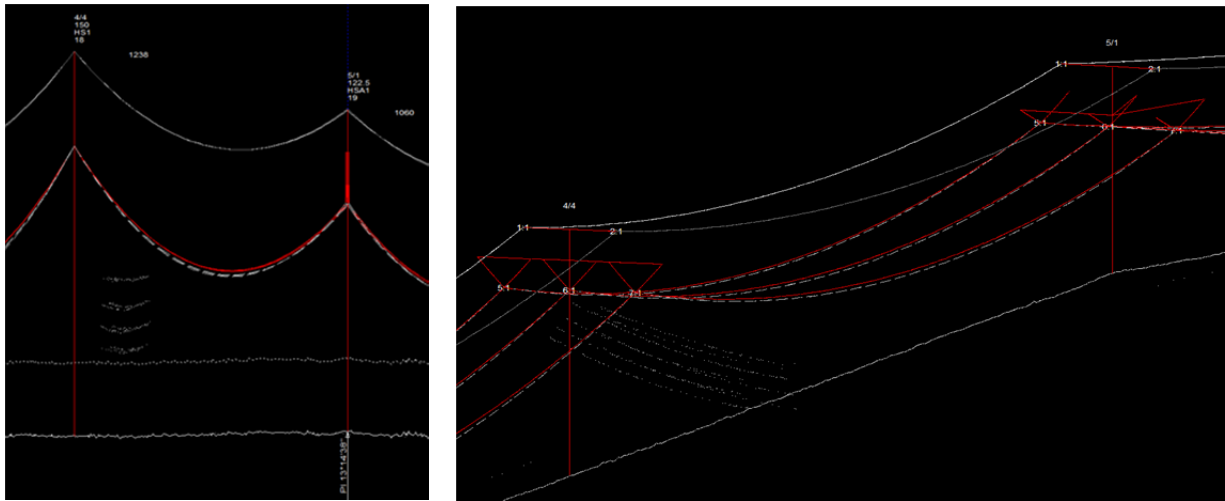
This line is built using lattice structures with an average span of approximately 1,300 feet. Typical tower heights are about 130 feet above ground.

Figure 1: Method 1 (Stick Structure) Models of Lattice Towers for Nip/Tuck

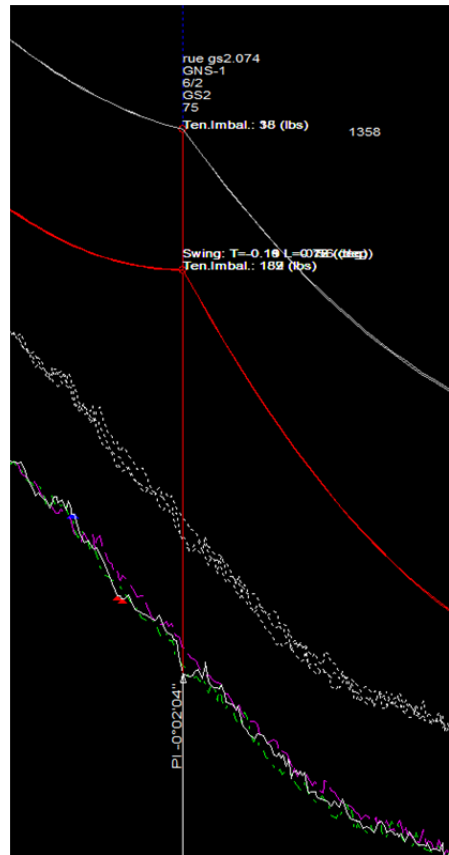
Figure 3: Structure 6/2 Sample of SAPs Insulator Swing and Tension Imbalance

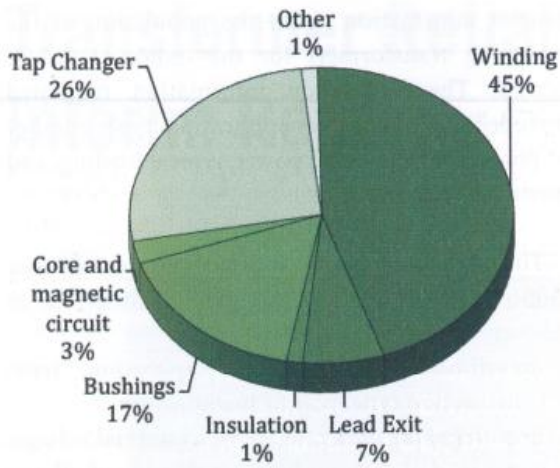
Figure 1: Failure locations of Substation Transformers (>100kV) (based on 364 failures)

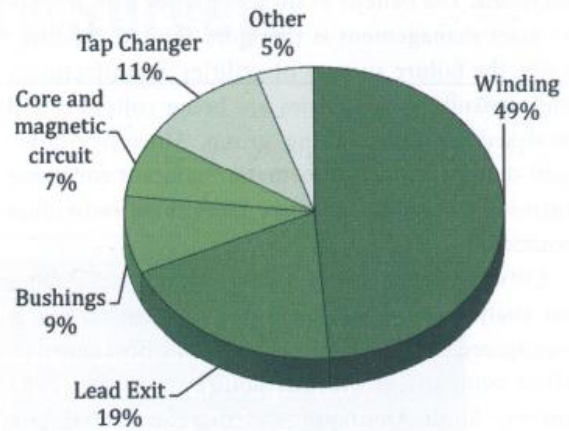
Figure 2: Failure Locations in Generator Step-Up Transformers (>100 kV) (based on 82 failures)

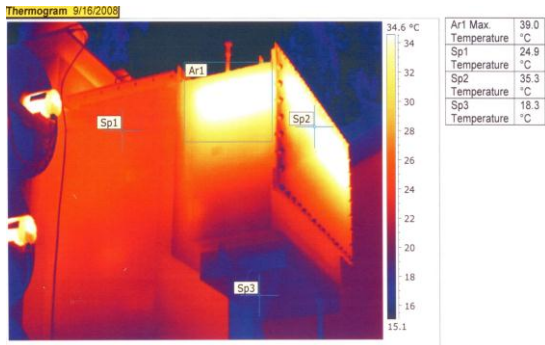
Infrared scanning of the cooling system (radiators and fans) can also be used to ensure that all equipment is functioning properly and provide designed temperature levels of the windings and other transformer accessories.

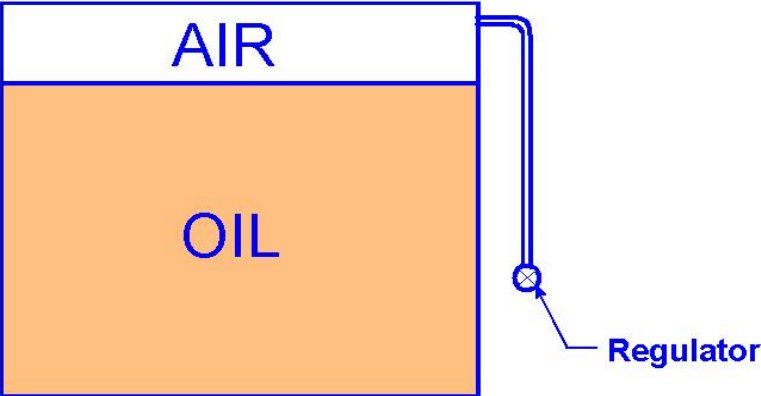
Inert gas oil preservation system designed to continuously maintain the nitrogen blanket above the oil.

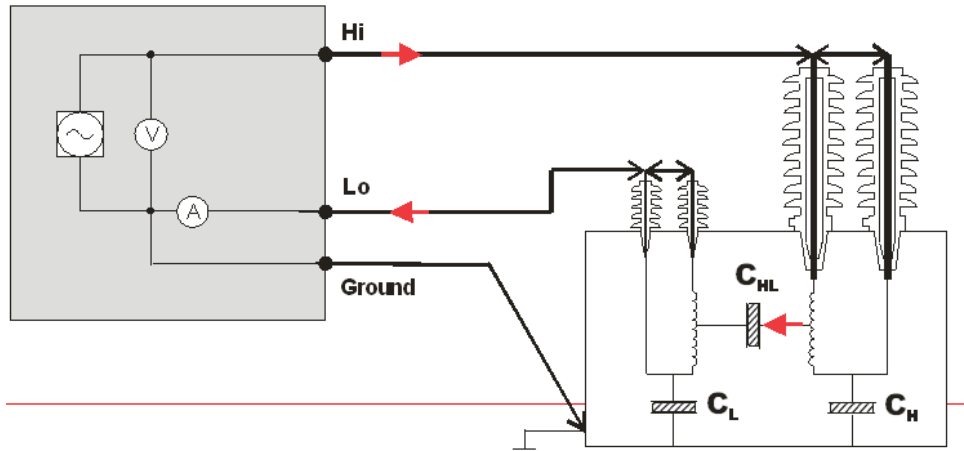
Figure 1. FDS measurements set-up for a two-winding transformer.

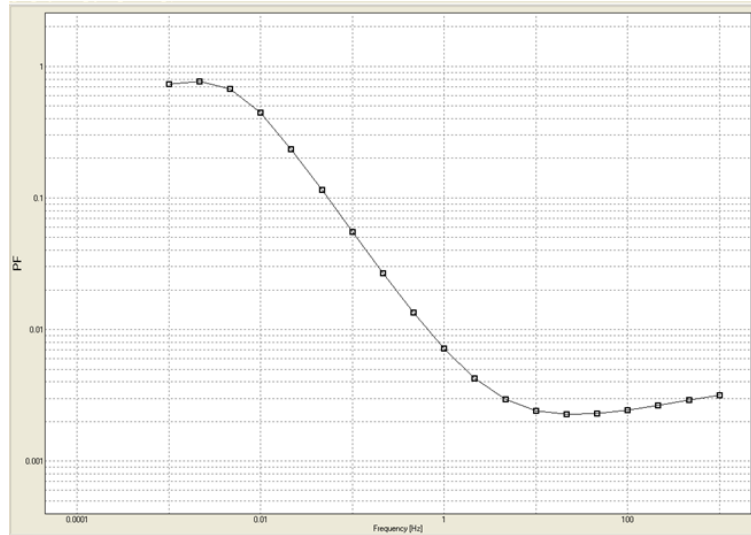
Figure 2 Typical dielectric response of an oil-paper insulation system

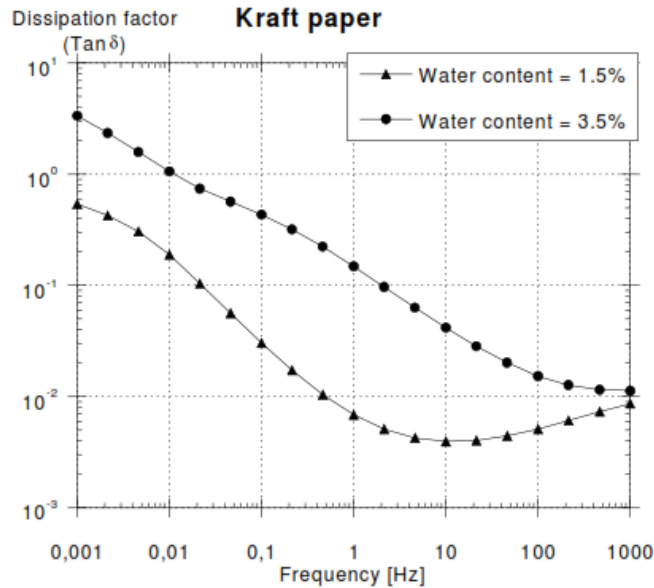
Figure 4 Frequency response of cellulosic insulation with different % m.c.

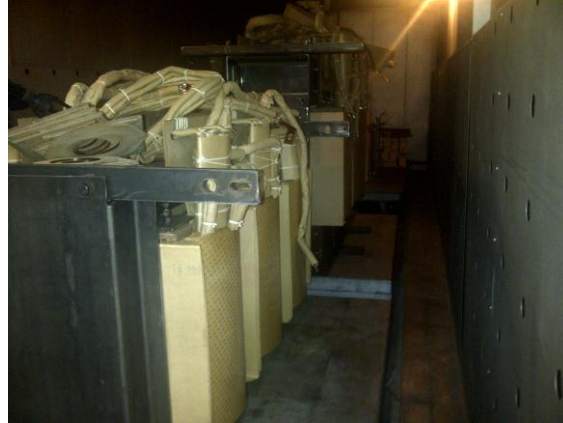
Figure 7 Core-winding modules set for thermal dry-out in the factory

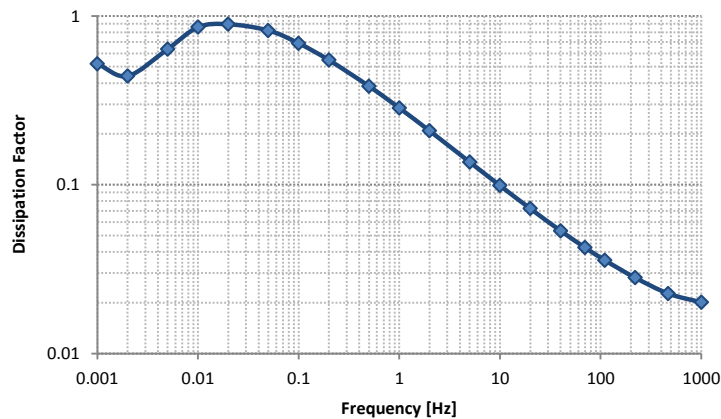
Figure 8 Dielectric Response of the active part of a distribution transformer before dry-out

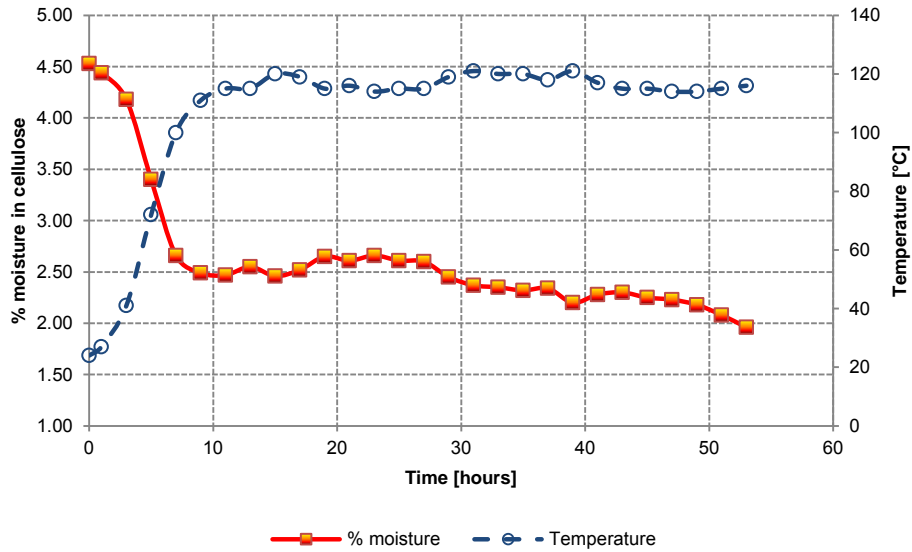
Figure 9 Moisture reduction under thermal effect on active part of a distribution transformer

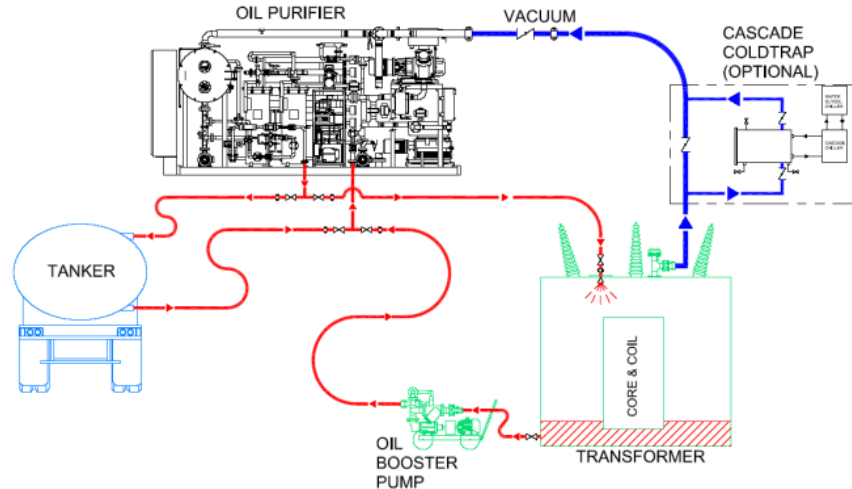
Figure 11 Typical setup for field off-line dry-out process

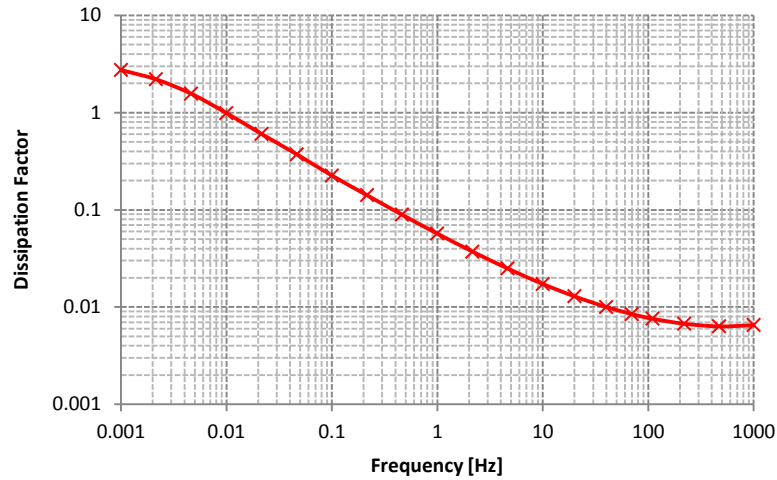
Figure 12 Dielectric response of a 5MVA transformer in the field with moisture content of 3.5% before dry-out process

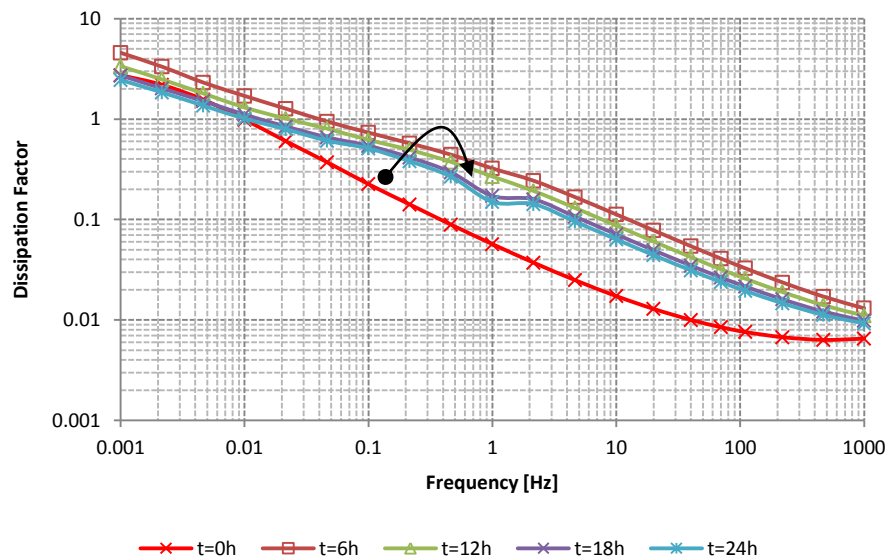
Figure 13 Dielectric response of the 5MVA transformer put under vacuum dry-out for 24 hours.

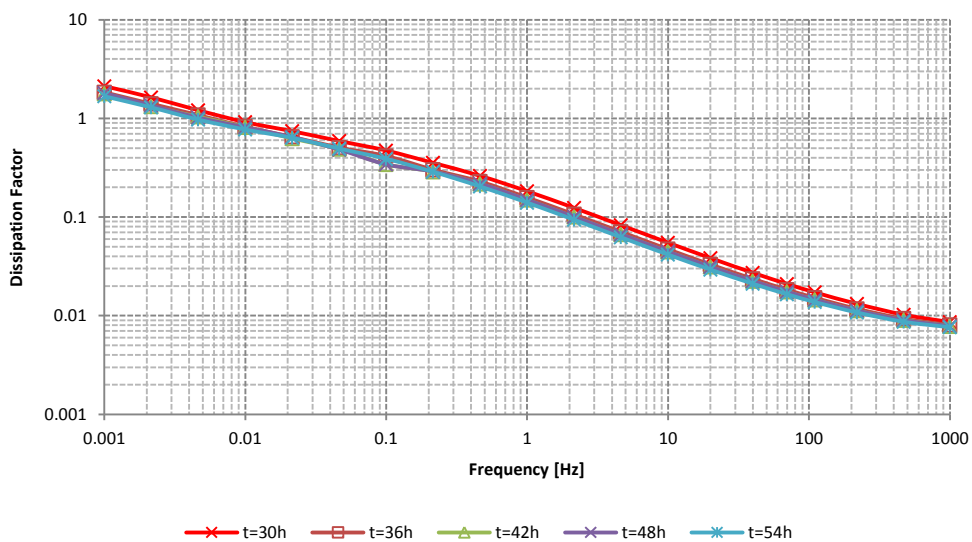
Figure 14 Dielectric Response of a 5 MVA transformer during vacuum dry-out. Interval from 30 to 54h

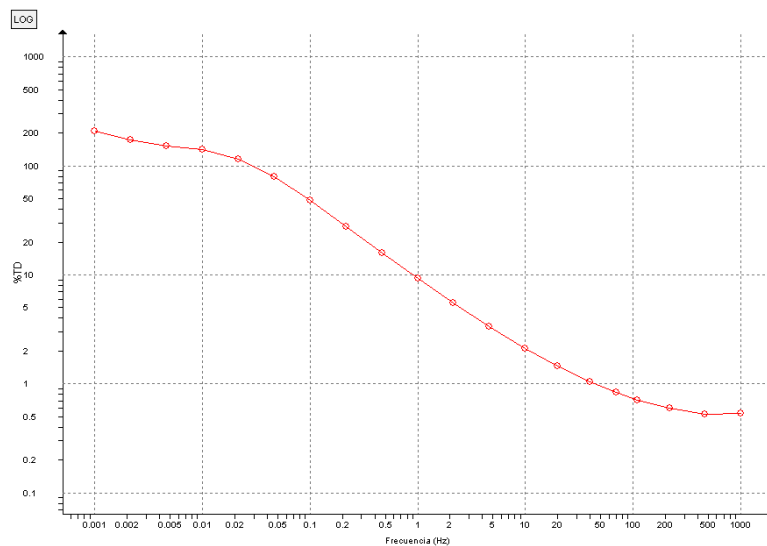
Figure 15 Dielectric response obtained after 2 weeks of operation after dry-out

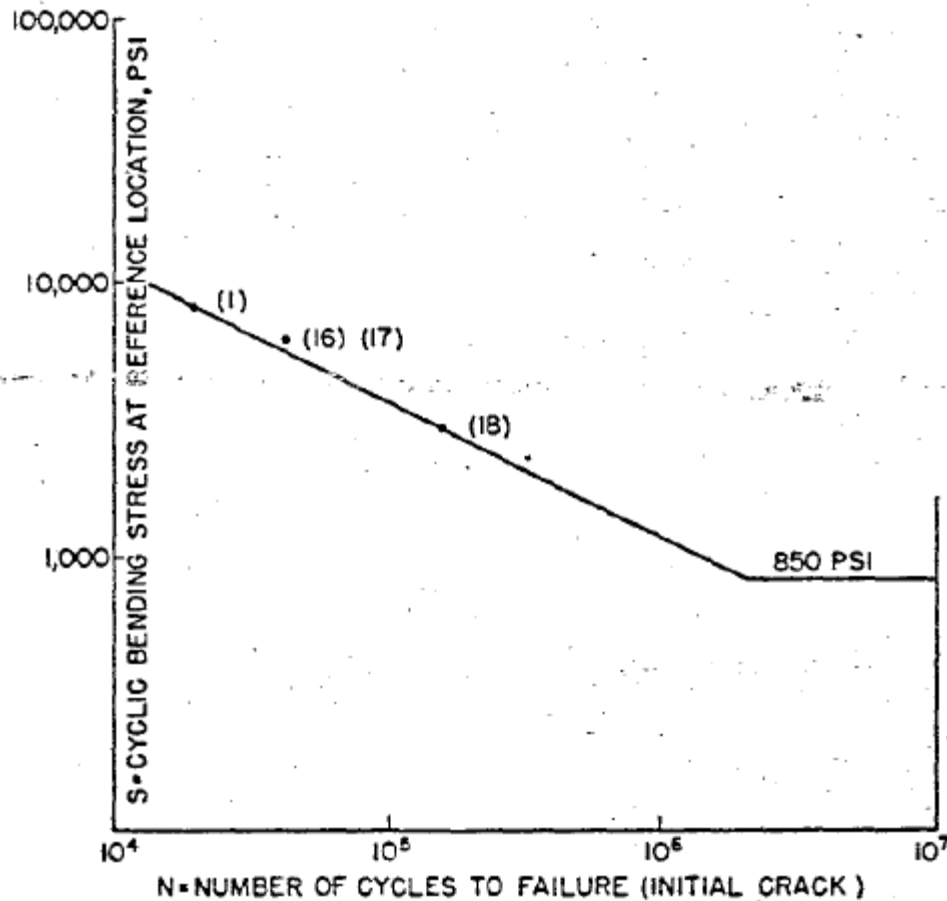
Fig. 5 Minimum Value S-N Diagram for Tests of Three Ground Wire Arms at Three Different Stress Levels.
