The 46th ANNUAL TSDOS

TRANSMISSION AND SUBSTATION DESIGN AND OPERATION SYMPOSIUM

September 11 - 13, 2013

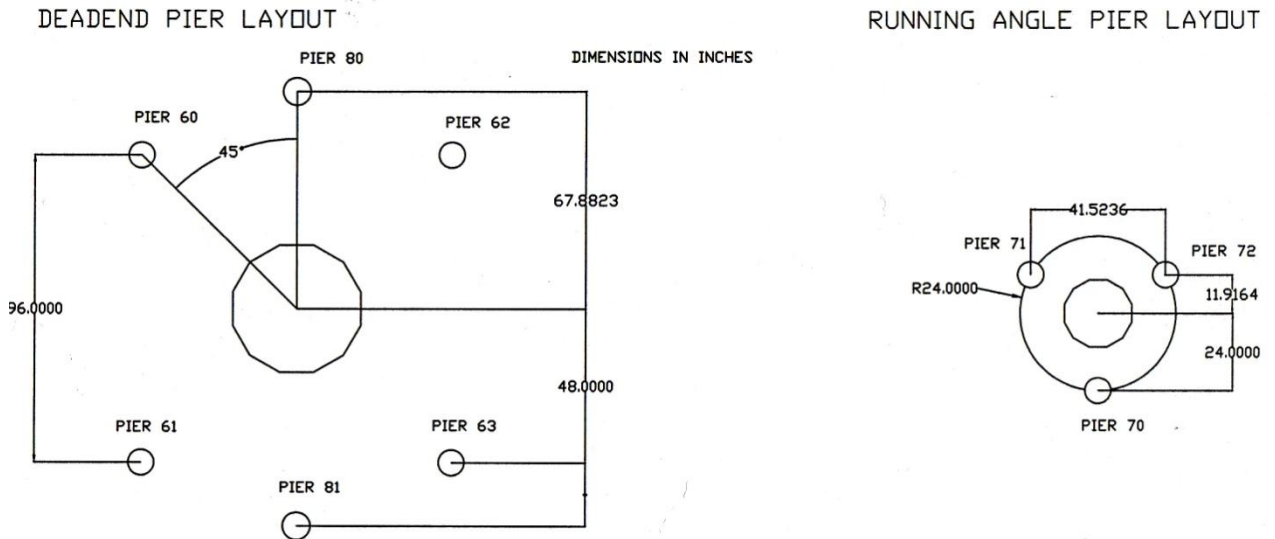
Figure 1. Location of Piles

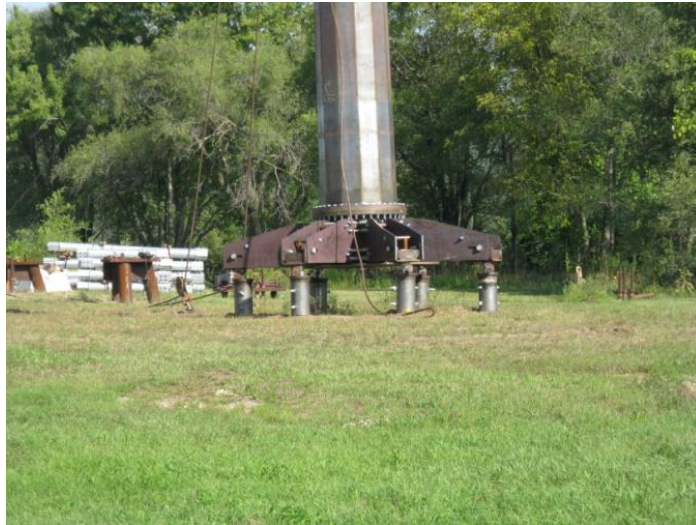
Figure 5. Deadend Load Case 1 100%

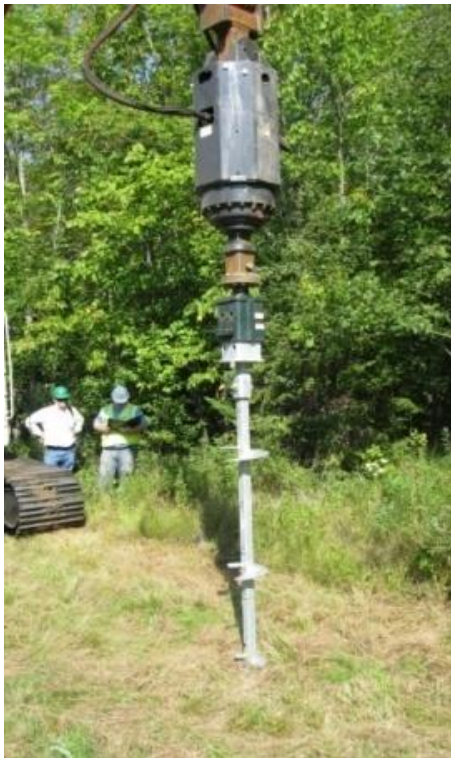
Figure 7. Three-Lead Helix.

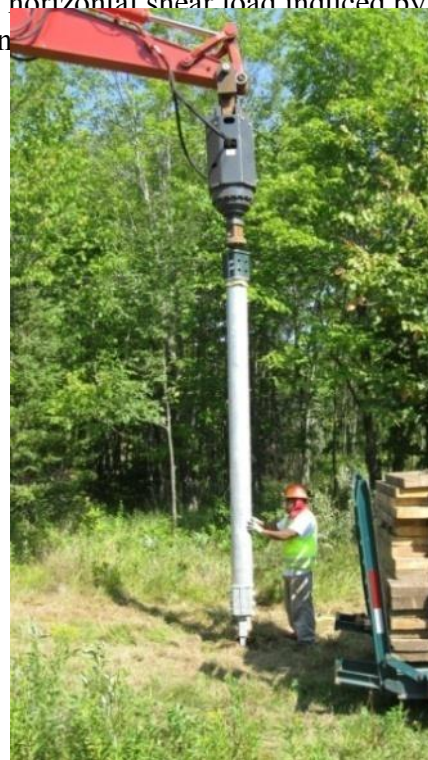
Figure 8. Eight Inch Diameter Pipe Extension.

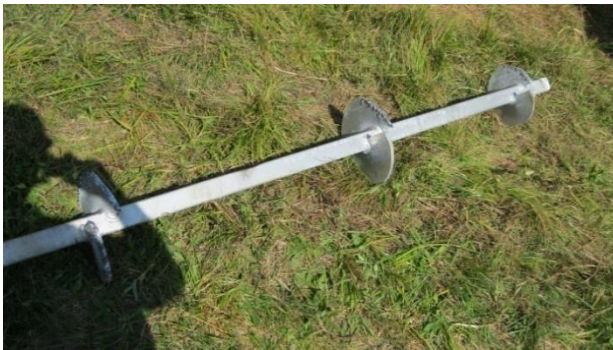
Figure 9. Modified Helices.

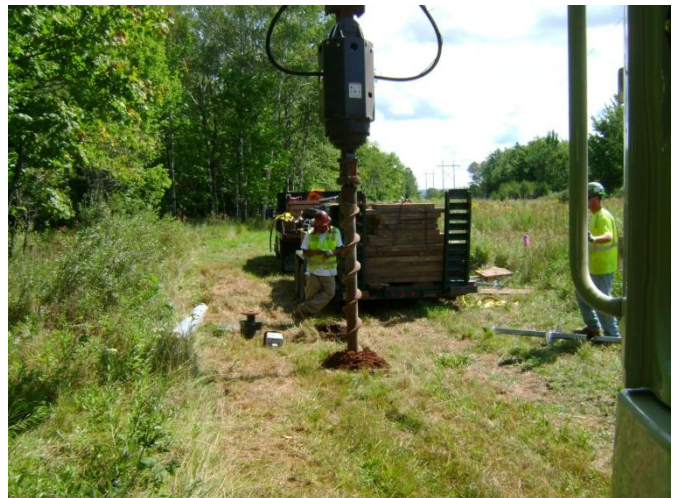
Figure 10. Pre-Augering.

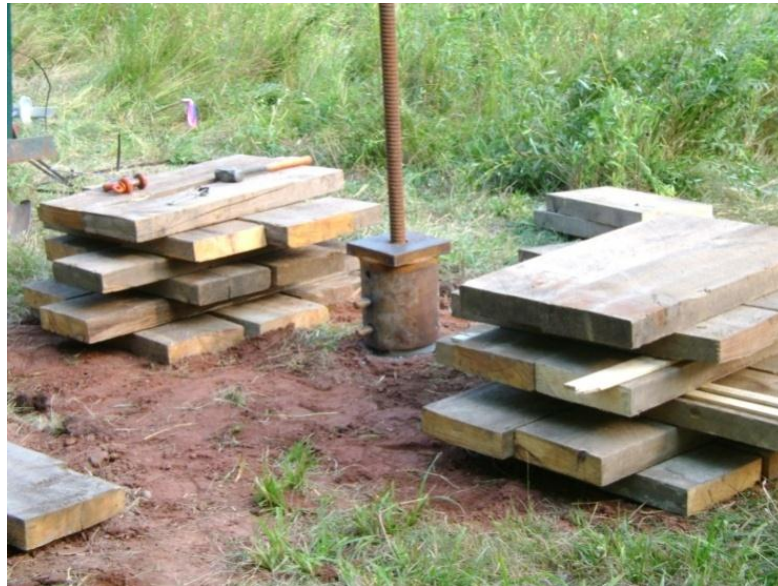
Figure 11. Termination Set-up.

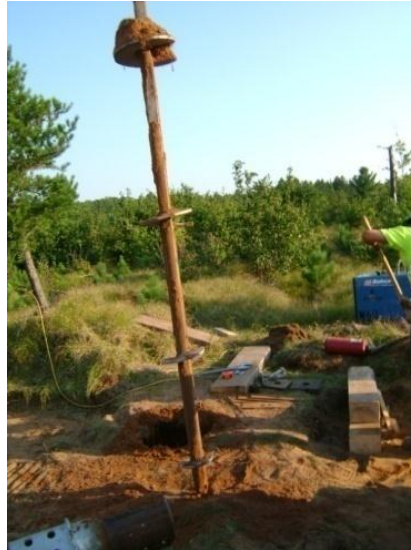
Figure 12. Four-helix Section.

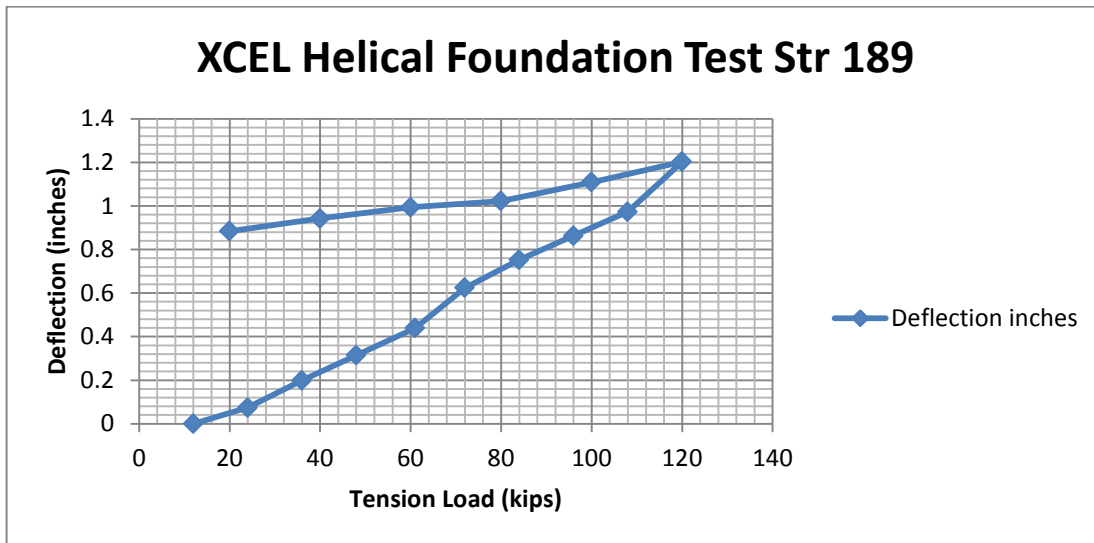
Figure 13. Axial Deflection versus Tension.

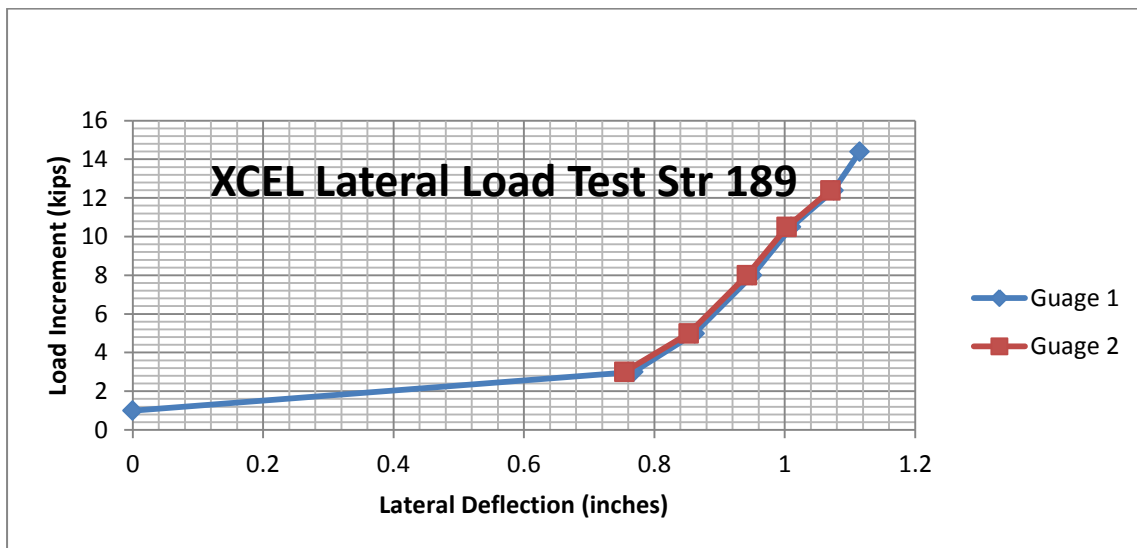
Figure 14. Lateral Deflection versus Lateral Load.
