Frequency Response Analysis: Failure Mode Analysis

Dinesh Chhajer, PE

Applications Engineers

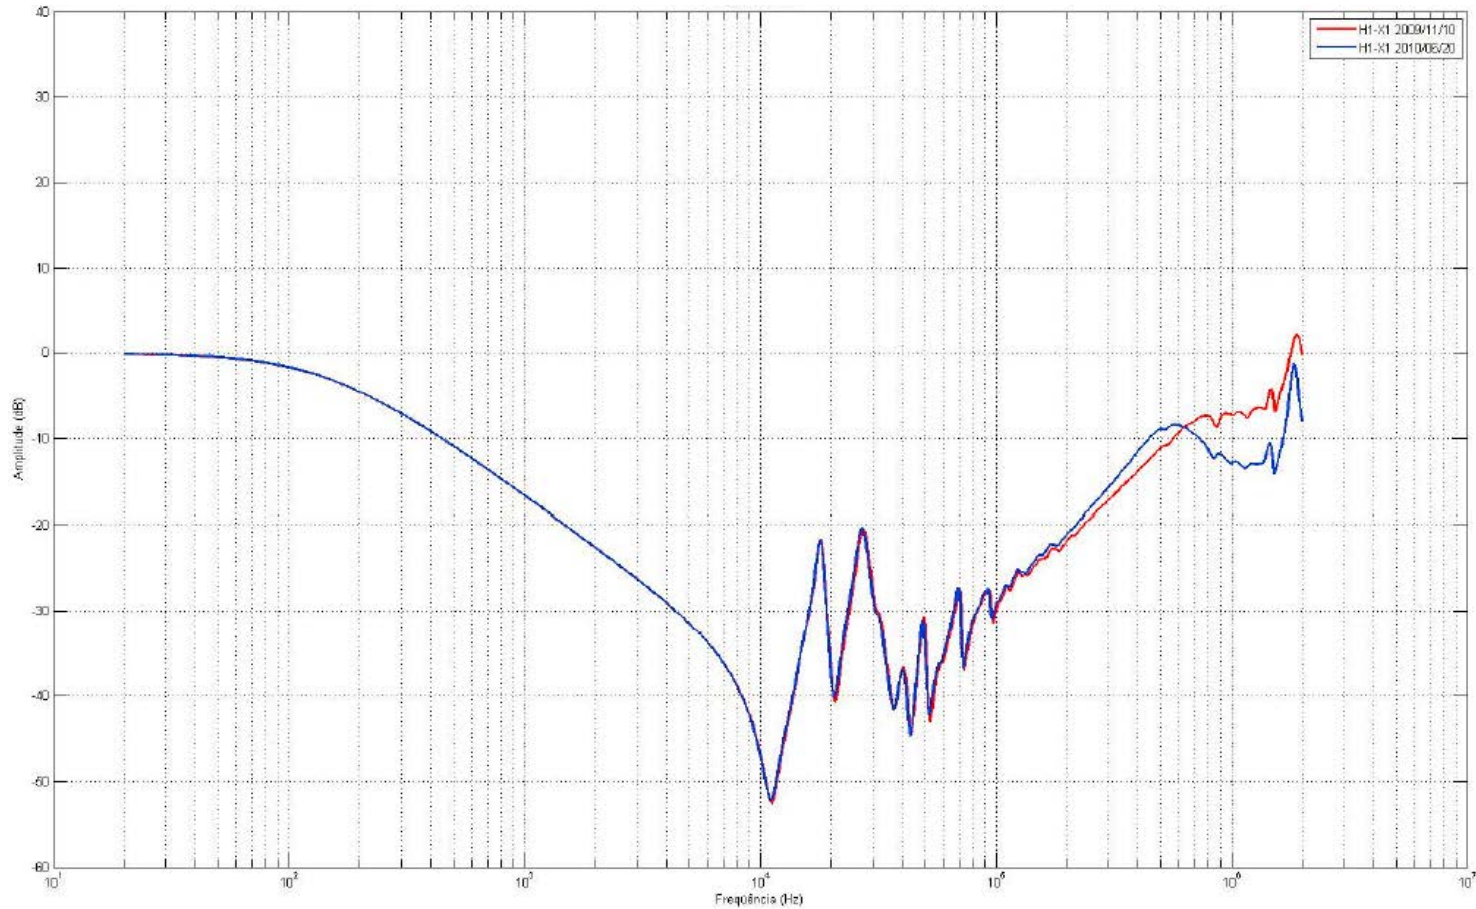
Auto Transformer 1

Comparison of short circuit responses before and after earthquake

- On evaluating the short circuit results, significant differences were observed in the following high frequency ranges:
 - Autotransformer 1: 150 KHz to 2 MHz
 - Autotransformer 2: 200 KHz to 1 MHz
 - Autotransformer 3: 700 KHz to 2 MHz

- A common characteristic for each comparison is an increasing magnitude difference in the high frequencies area. This is a typical indicator of winding looseness as described in the failure modes section of IEEE guide.
-

- It was decided to inspect the transformers on site.
- Visual inspection was performed and it was found that the three autotransformers were longitudinally displaced.
- There was a bigger separation between the turns of the winding due to the loosening of the blocking structure.
- The FRA diagnosis was able to detect the internal winding movement and issue was resolved at site by transformer manufacturer before the commissioning of the auto transformers.

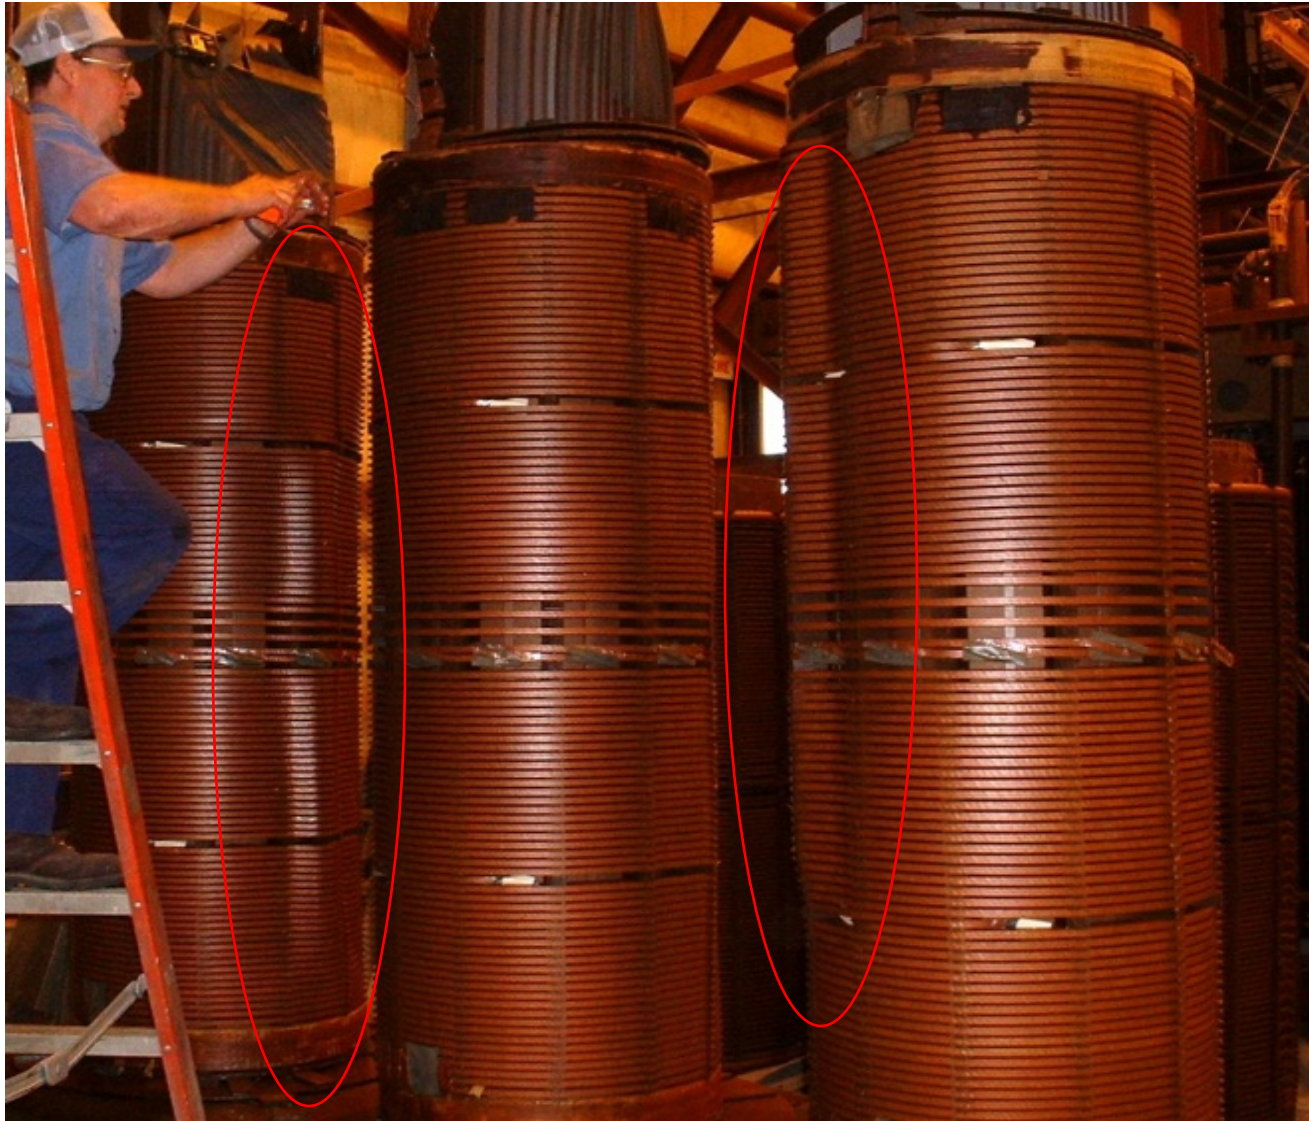
Winding Radial Hoop Buckling

- Upon de-tanking and tear down, it was found that all three low side windings were severely deformed showing signs of radial buckling due to lack of strength to withstand through fault conditions.
- After diagnosing the problem, the transformer was rebuilt and put back in service at a different location.
- A new FRA fingerprint was taken before putting it back in service for any future investigation and analysis.

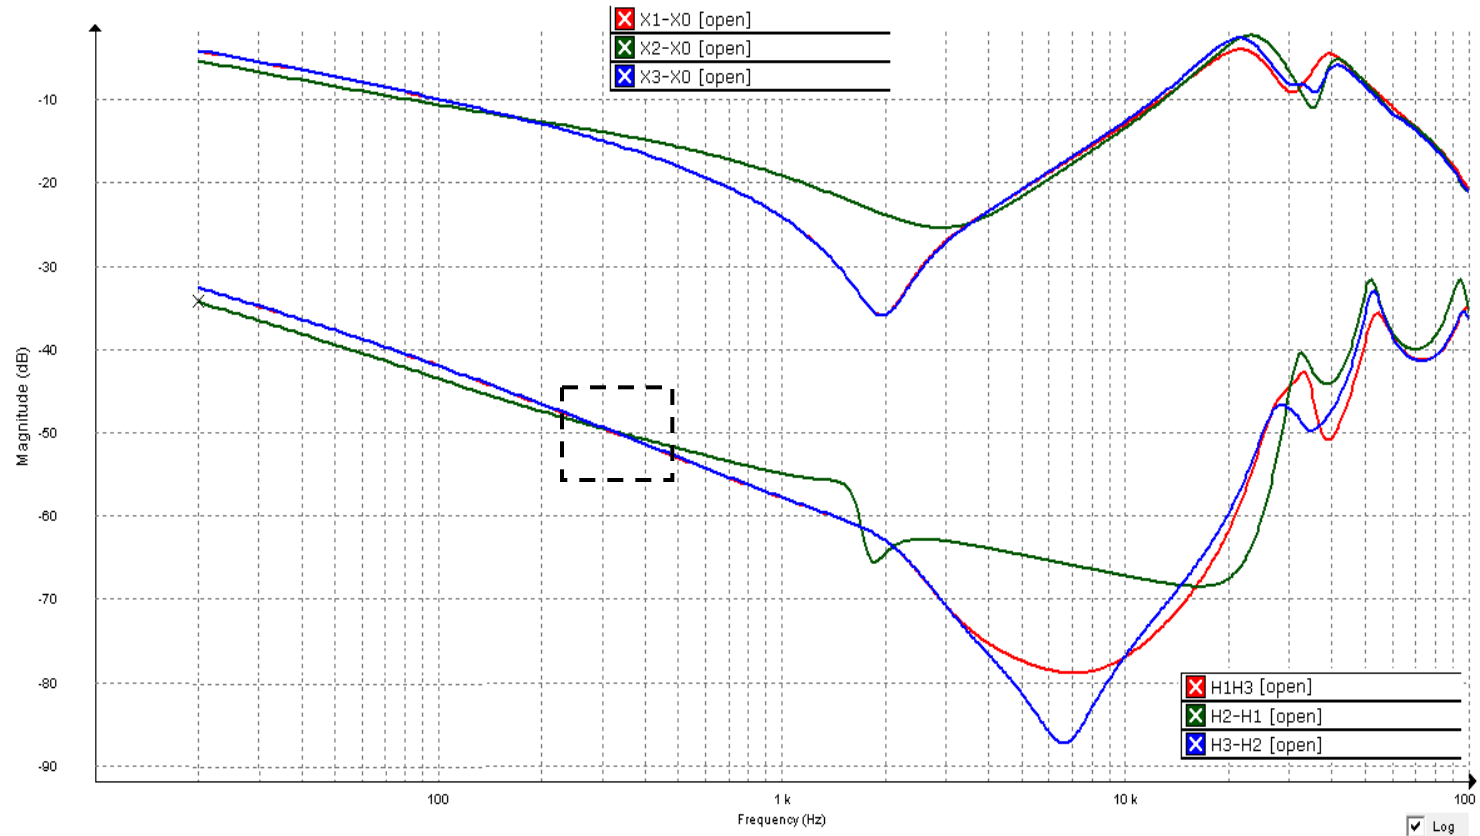
Open circuit results for HV and LV sides for all the three phases

- B phase trace which usually have a distinct pattern and offset throughout the low frequency region up to 1 kHz showed a cross over point where it crossed A and C phase traces. This kind of response is unusual and typically not expected.

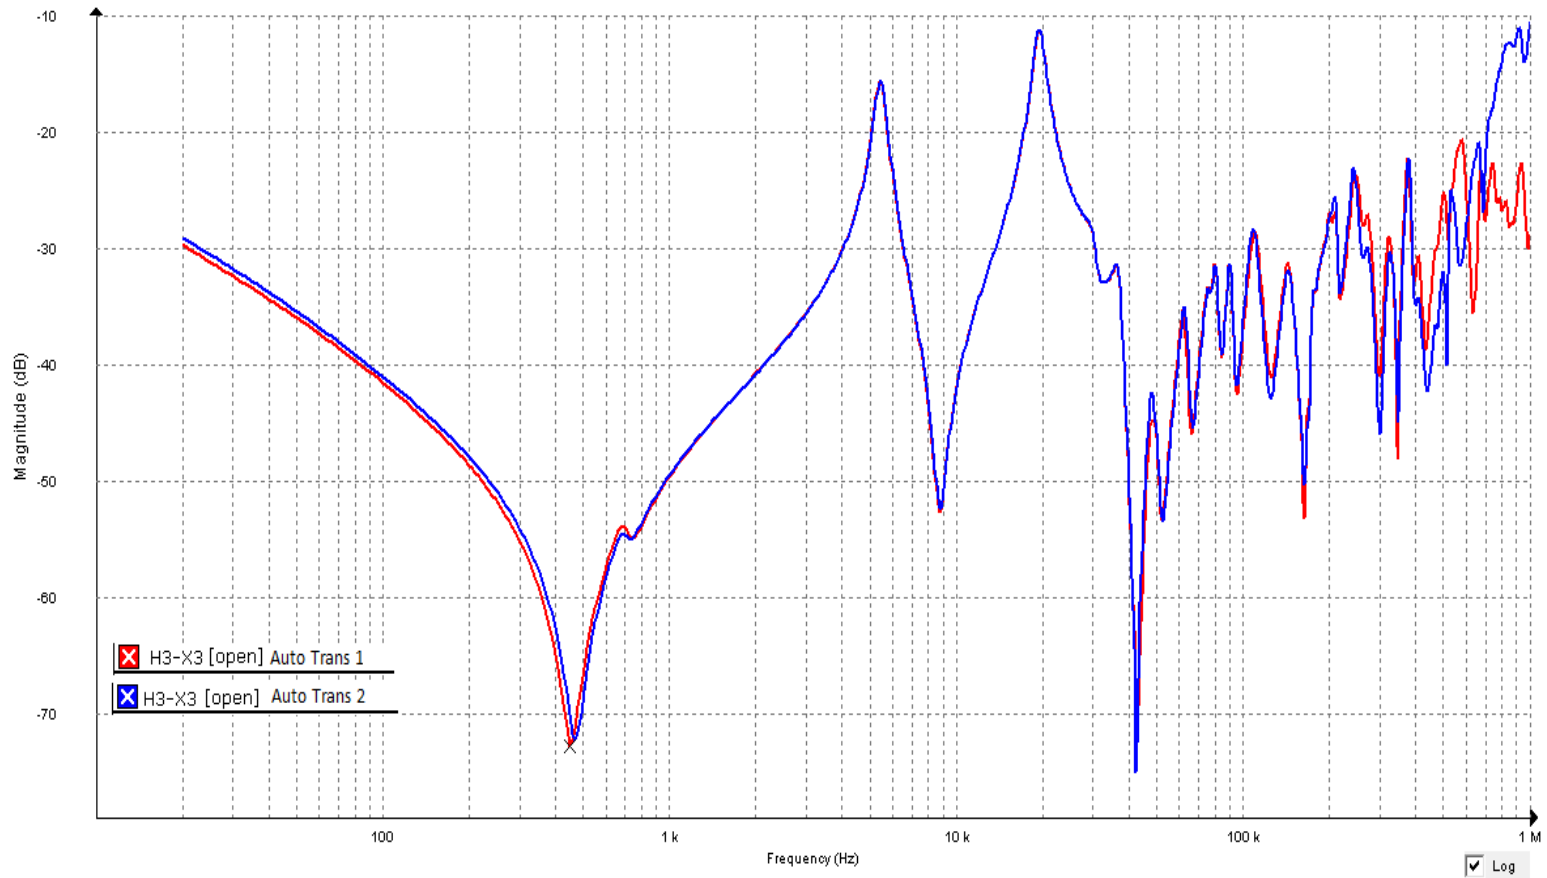
Comparison of phase C of autotransformers 1 and 2

- FRA trace comparisons between respective phases of two auto transformers showed a lot of symmetry for A and C phases with some curve mismatch in mid to high frequencies
- Phase B comparison showed shift in resonance, change in magnitude and loss of resonances in frequency range from 200 Hz to 600 kHz
- Phase B traces from two transformers were further compared in narrow frequency bands of 20 Hz -10 kHz and 5 kHz -100 kHz

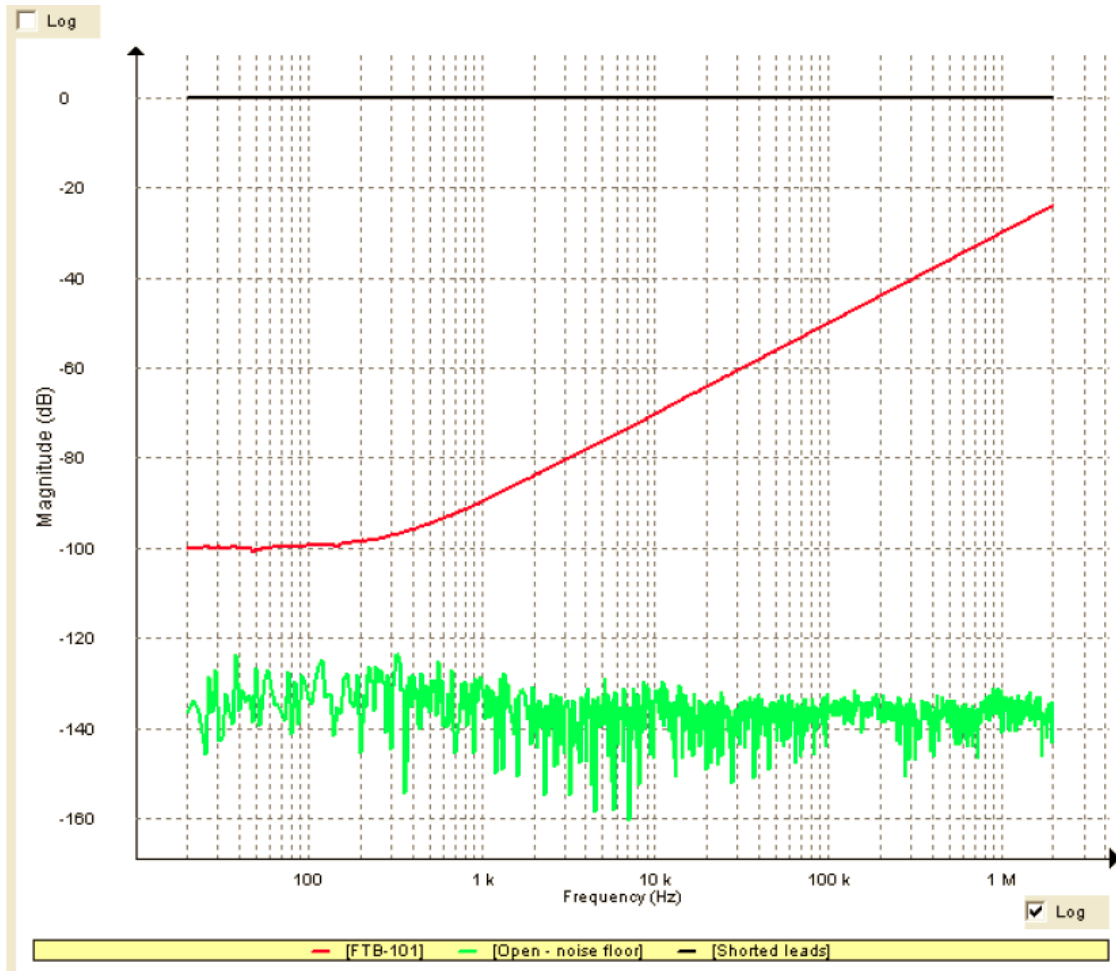
Instrument Verification

- The test equipment should always be checked for its performance and validity using the supplied test leads before initiating the FRA test on a specimen.
- Cigré recommends running integrity verification with an object of a known response . A standard test object is usually offered by the test equipment manufacturer.
- In the absence of that, as an alternative, self check can be performed by shorting the test leads together, the user should expect a zero dB response.

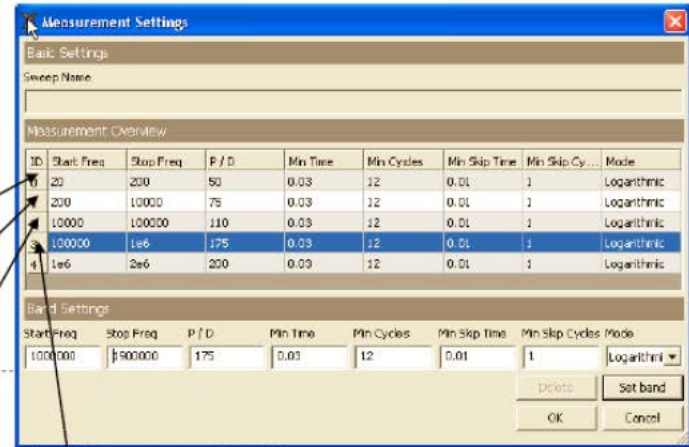
- It is advisable to have less measurement points (50 per decade) in lower frequency region and as frequency increases, more measurement points are added (200 per decade in highest frequencies).

It provides the desired resolution and accuracy both in low and high frequency regions.

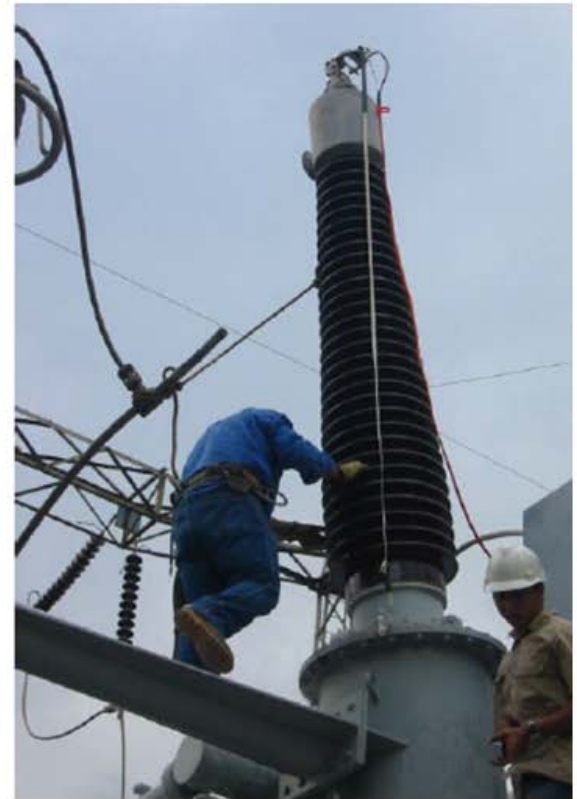
Best grounding practices in field environment
